**CITY OF NEWARK  
DELAWARE**

**CITY COUNCIL  
WORKSHOP AGENDA**

## Storm Sewer Investigation and Planning

- Storm Sewer Investigation
  - Pennoni was hired to assist Newark with visual observation and assessment.
  - Used Envirosight pole camera to scope existing system for existing and potential future problems.
  - Video information supplemented with notes and photographs.

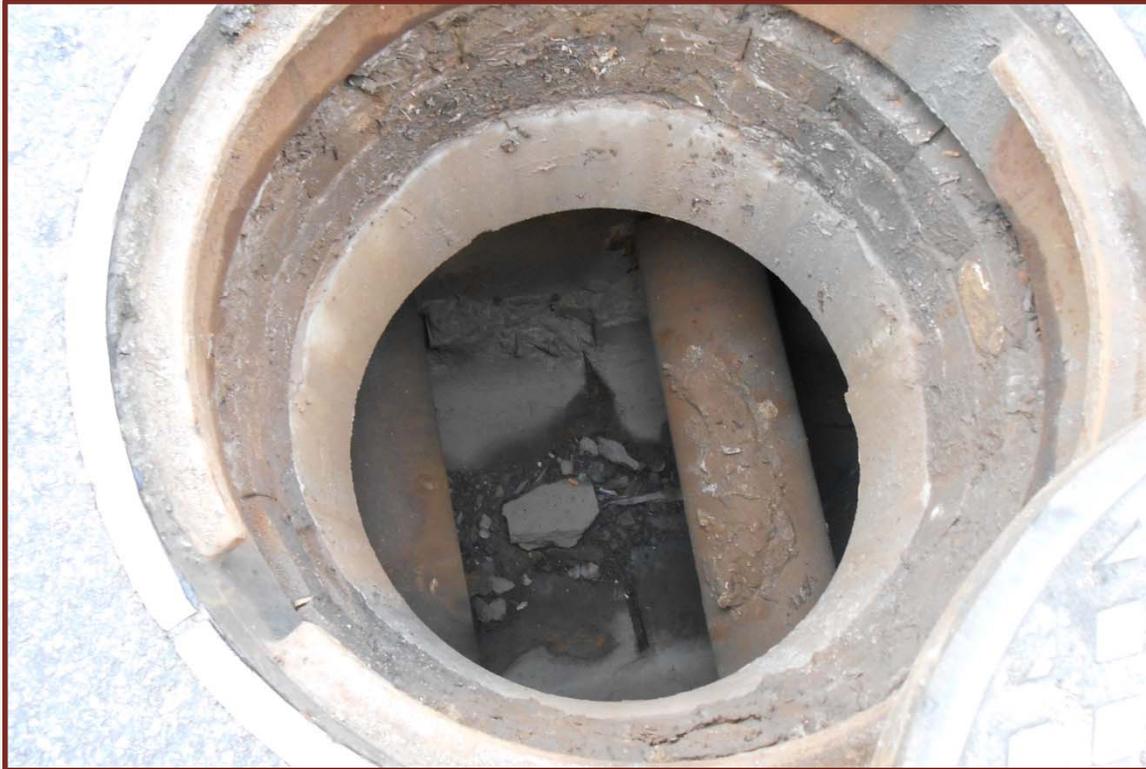
## East Main Street – Inlet 366

Near 133 East Main Street  
Left – Inflow pipe (24" Diameter)  
Above – Outflow pipe (15" Diameter)

- Short Term Action Items
  - East Main Street
    - Analyze drainage area upstream of inlet 366 to determine adequate pipe sizing (2013)
    - Address pipe size reduction at manhole 366 by replacing the existing pipes and modifying the pipes connecting to manhole 76 and inlet 367 (2014)
  - Julie Lane/Leroy Hill Ball Field
    - Soil Remediation and berm installation as part of Parks Department project(Fall 2014)
    - Install new culvert end protection

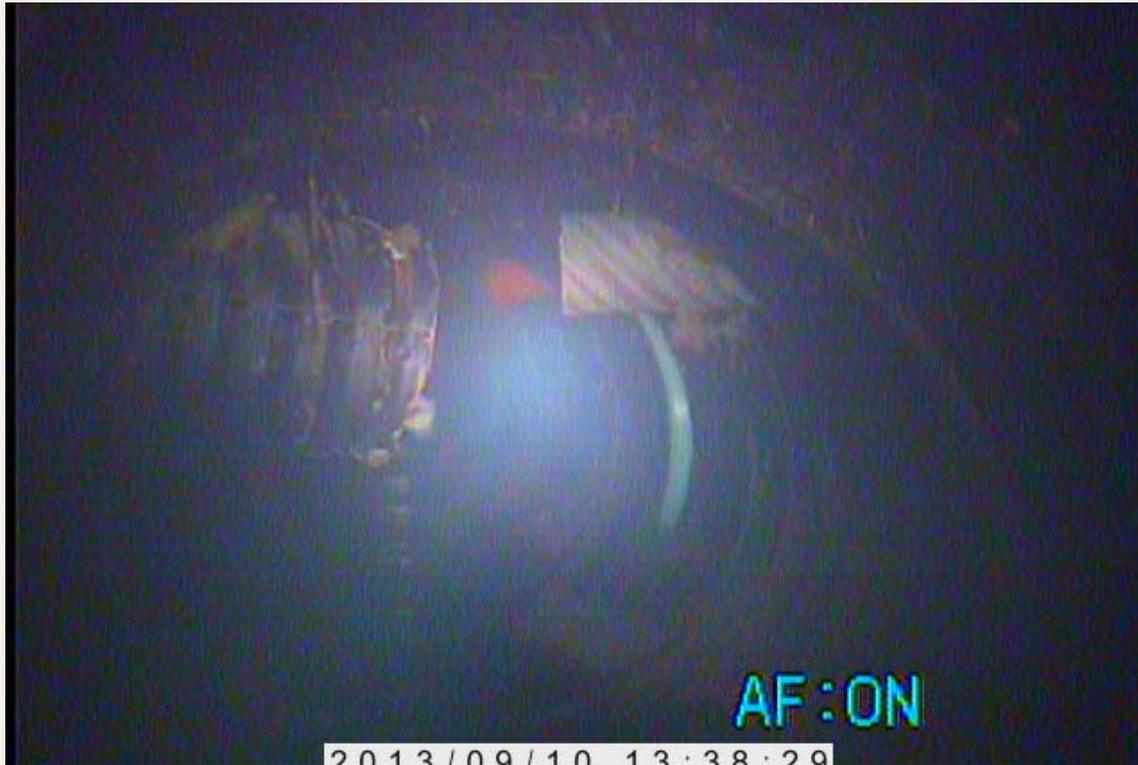
## East Main Street Blockage

Just west of Academy Street

Internal pipe photo looking upstream from Inlet 66 showing a pipe crossing and debris accumulation.

- Long Term Action Items
  - East Main Street
    - Remove or relocate utility crossings where possible or install access points at the crossings to enable maintenance for removal of debris
    - Prepare drainage area model to determine system capacity
    - Develop construction project to address capacity problems and replacement of deteriorated pipe if necessary
    - Consider modifications to City regulations regarding storm sewers

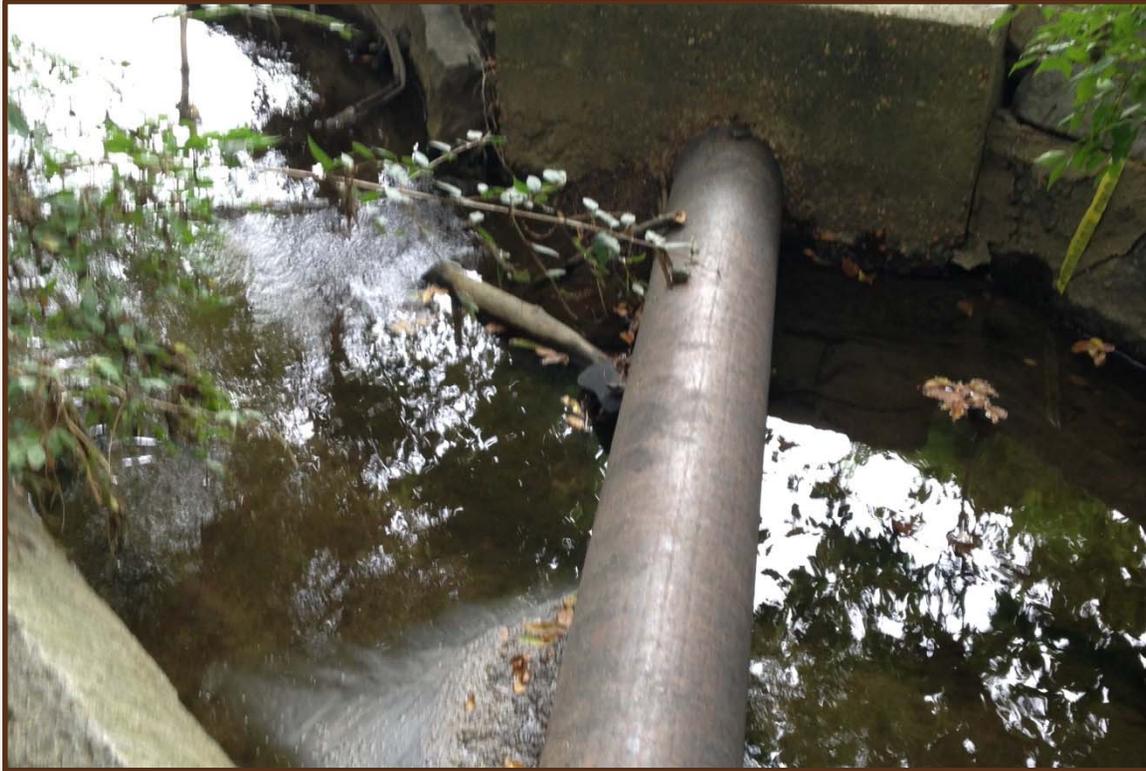
## Sanitary Sewer Crossing Storm Channel

Sanitary sewer main crossing stone storm channel at east end of Kells Avenue to be addressed by sanitary sewer project

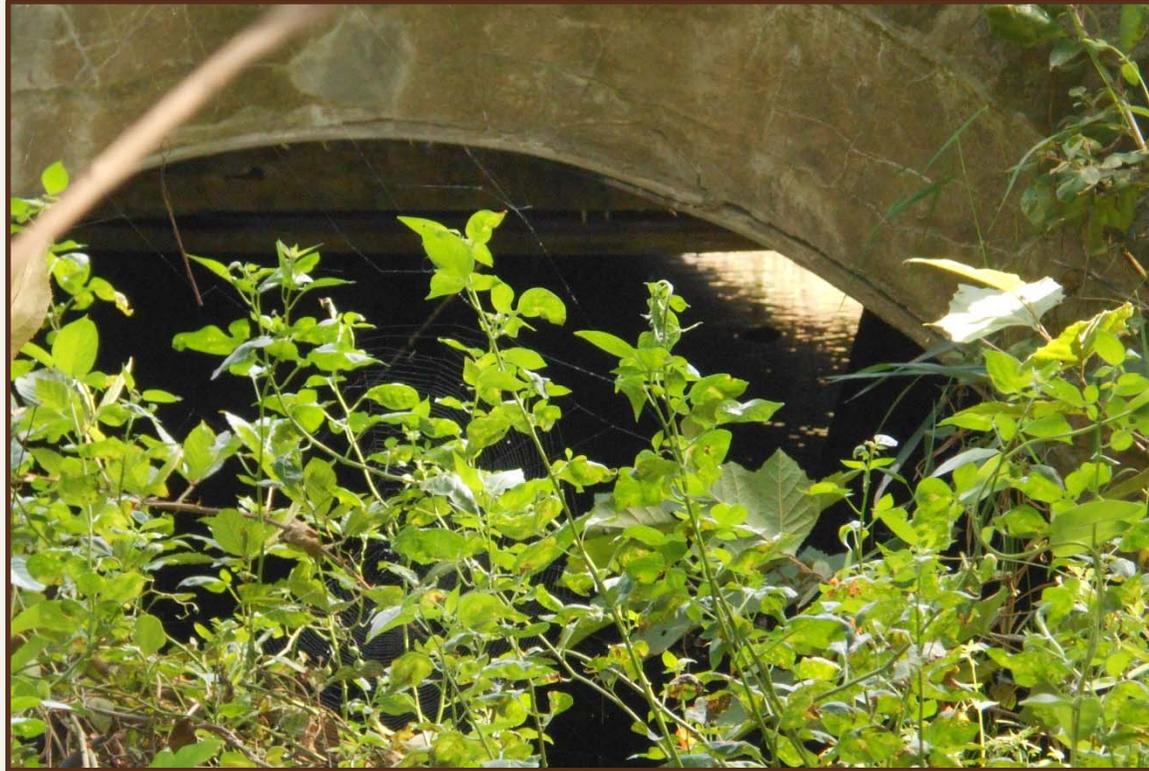
## Overgrown Vegetation

Vegetation growth at Headwall 26A for pipe under Amtrak Railroad south of Kells Avenue

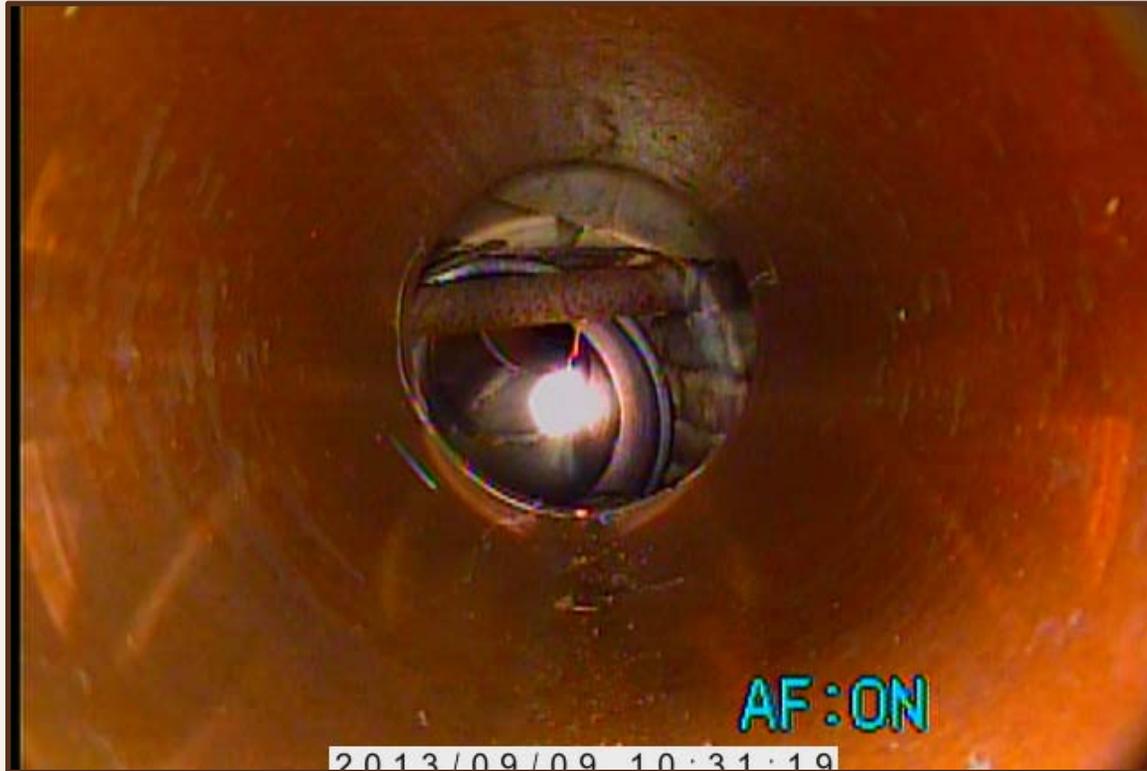
## Utility Pipe Crossings

Near Inlet 22 on Kells Avenue

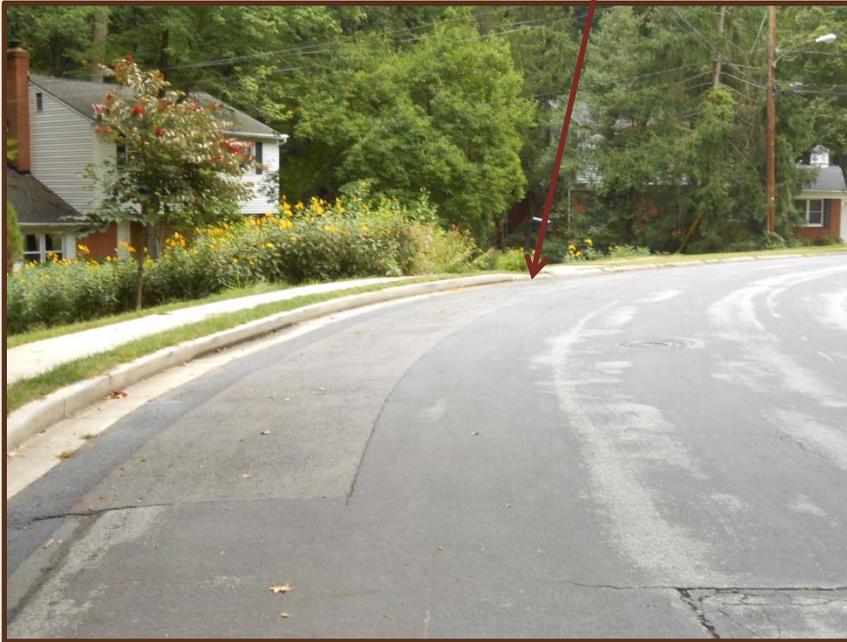
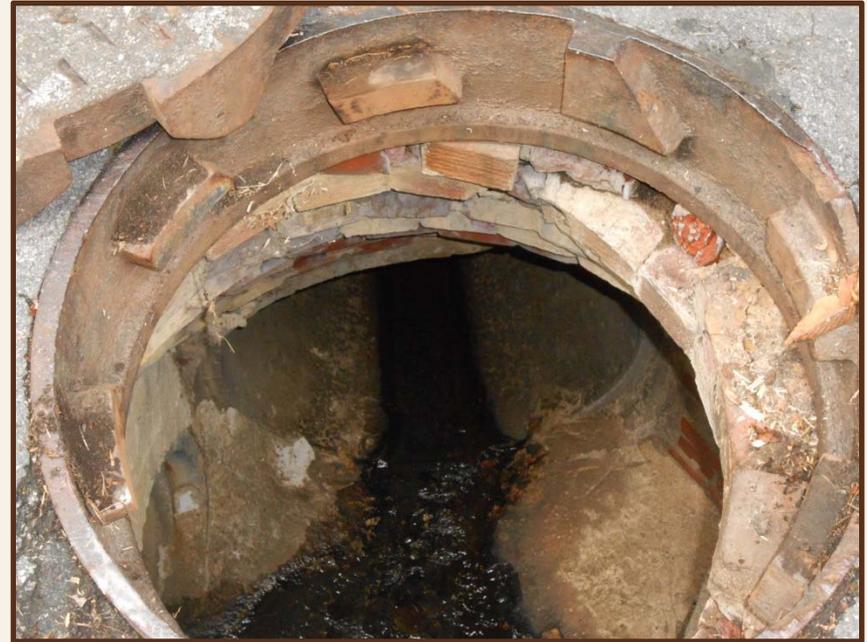
## Arbour Drive and manhole 215

Left – View from Inlet 213 to east showing upright curb and transition to roller curb near driveway  
Right – acute flow angle and opposing flow channel in manhole 215 (damaged frame, deteriorated chimney)

- Long Term Action Items
  - Arbour Drive
    - Modify sewer alignment at manhole 215 to eliminate acute flow angle
    - Investigate the addition of new pipes and inlets along downslope of Arbour Drive to collect gutter flow.

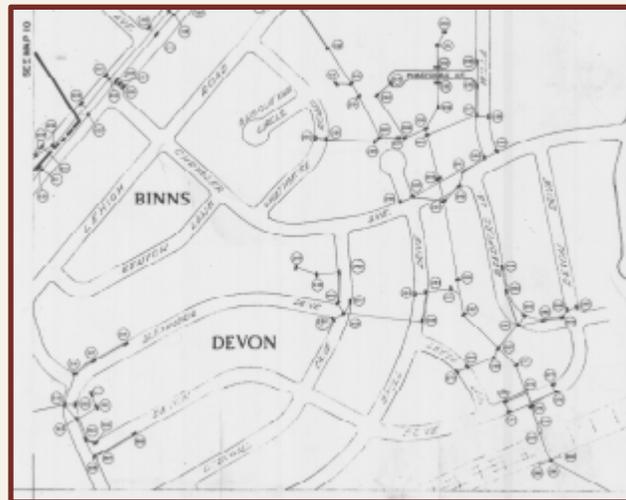
Devon Place, as represented below on the Newark Storm Sewer System Map Sheet 11, has fewer structures for surface runoff compared to other areas of the city. Impervious cover has increased since construction and is contributing additional runoff to the existing facilities.

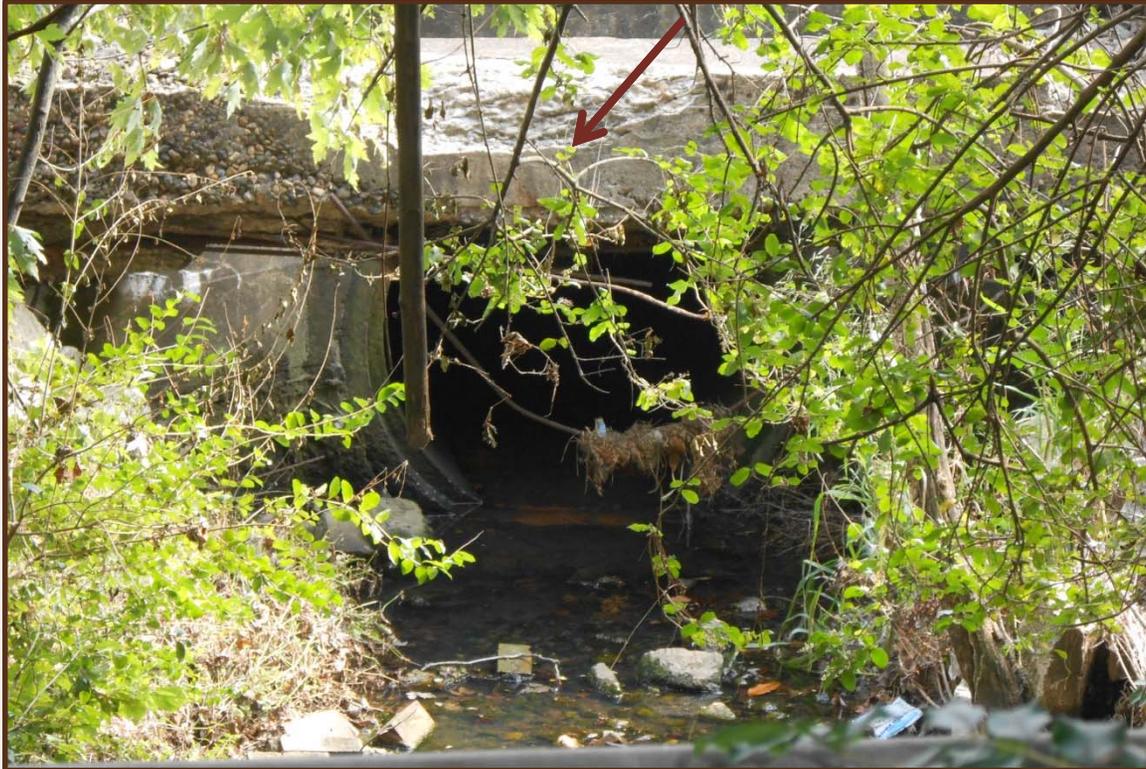
## Obstruction at Headwall 279

Obstruction in front of the top of pipe at Amtrak Railroad crossing to downstream system on former Chrysler site

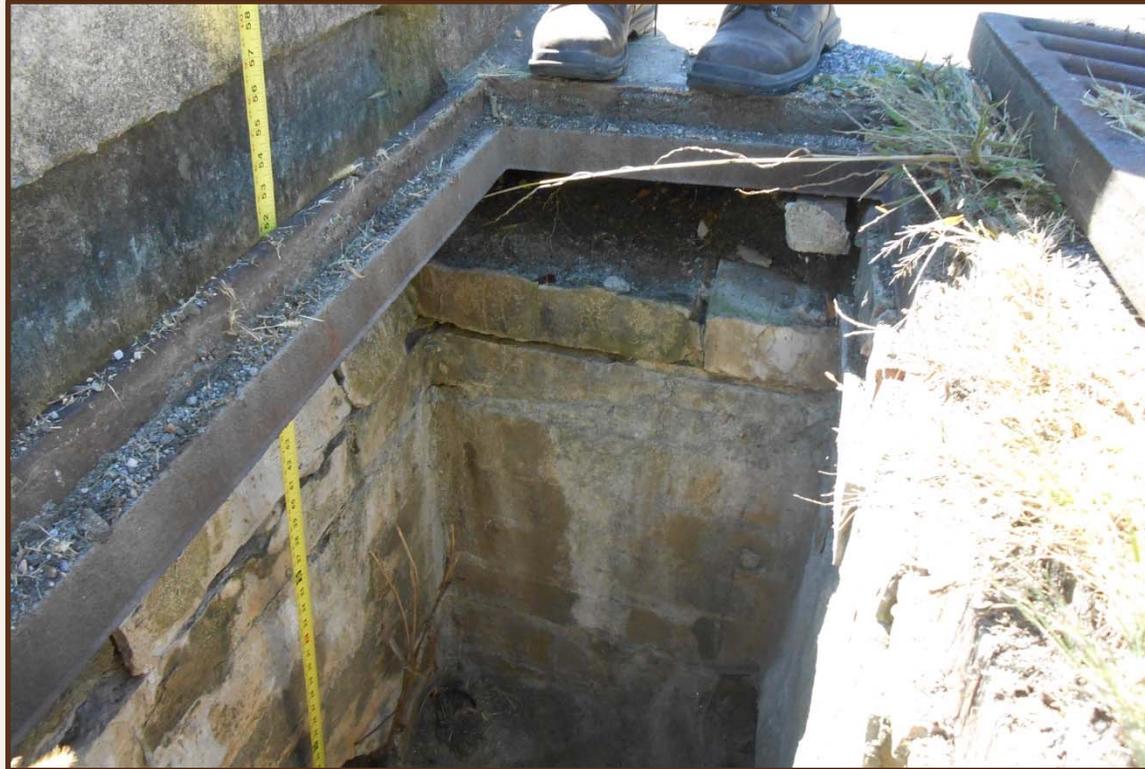
## Julie Lane at Sue Lane – Inlet 58

Deteriorated walls missing brick and mortar enter storm sewer and may contribute to debris build-up

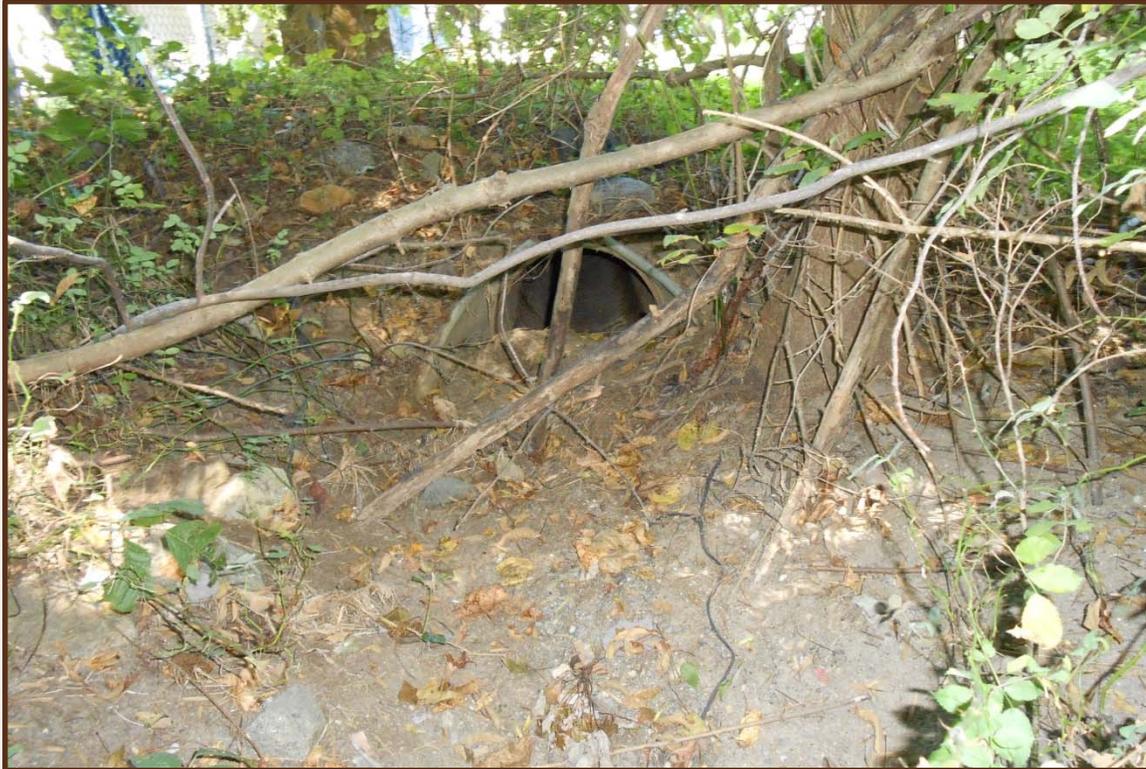
## Julie Lane – End Section 69

Vegetation and yard waste blocking the outlet.

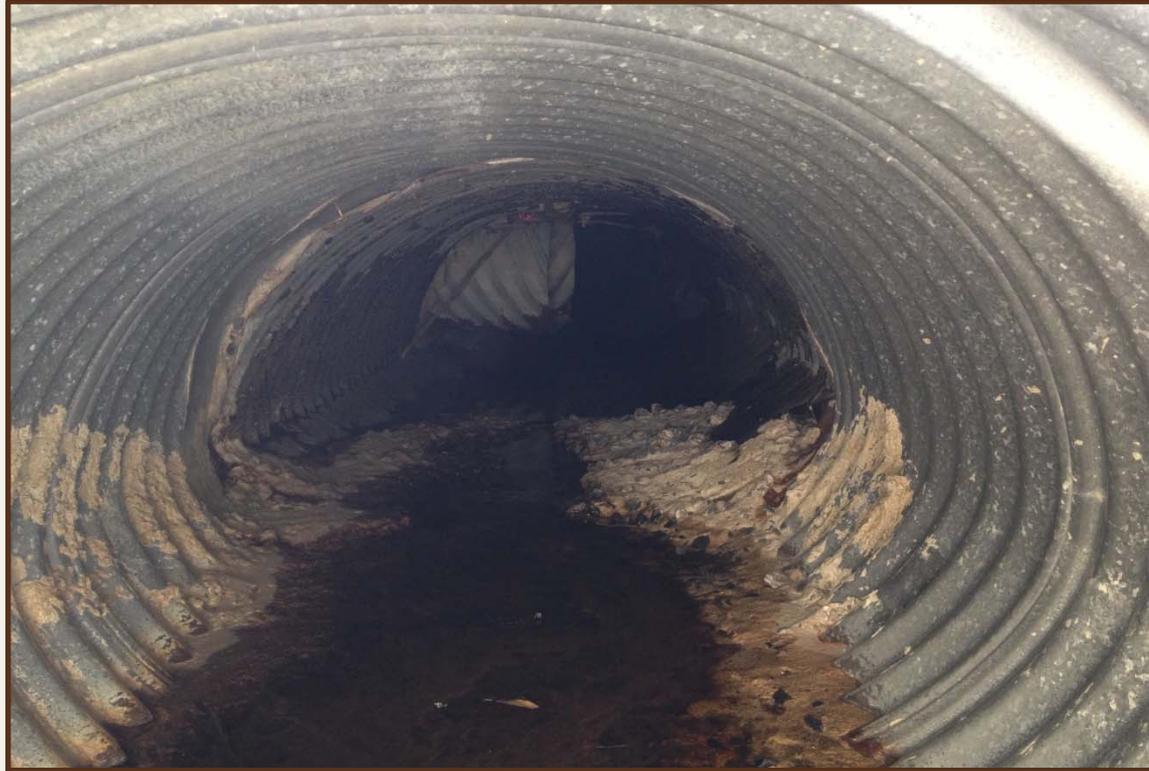
## Casho Mill Road Culvert

Near Blair Court, south of Barksdale Road

Protruding storm sewer pipe connection to be addressed by current DELDOT project.

- DELDOT project to correct pipe protrusion (November 2013)

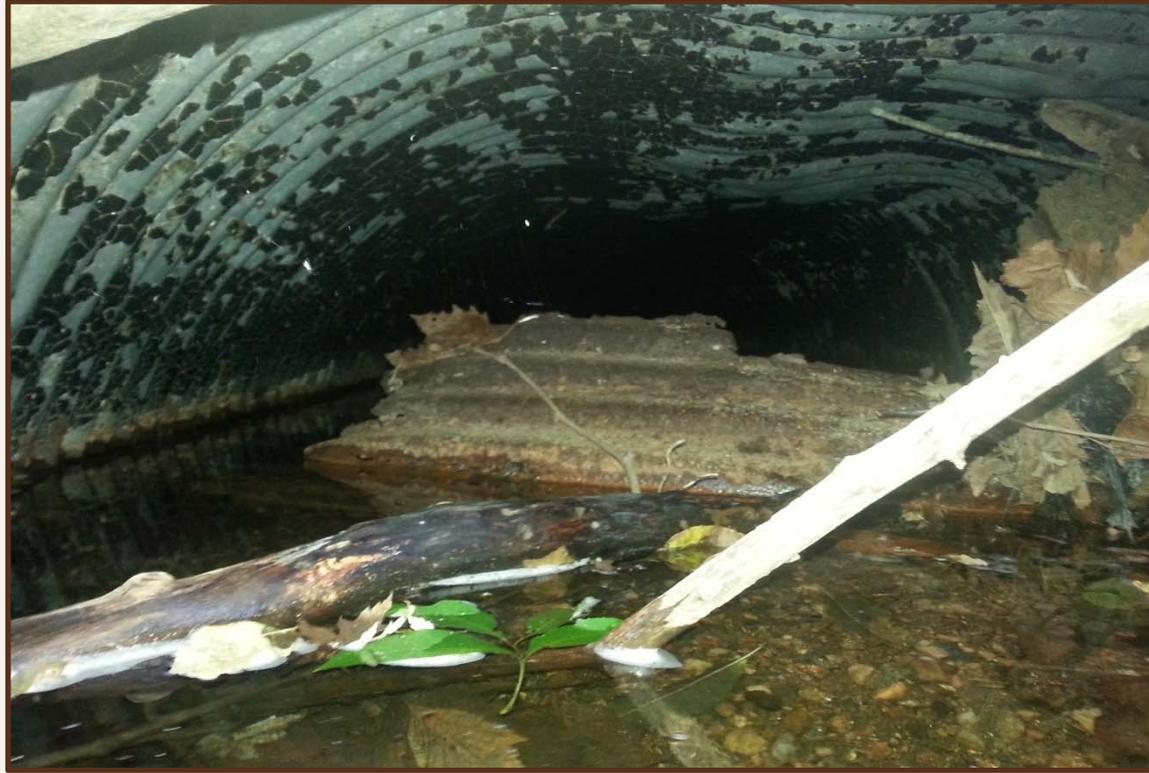
## Paper Mill Road Culvert

The existing CMP is partially blocked. The pipe condition is deteriorating.

- Long Term Action Items
  - Paper Mill Road Culvert
    - Prepare drainage area model to determine system capacity
    - Develop construction project for pipe replacement and possible water main adjustment

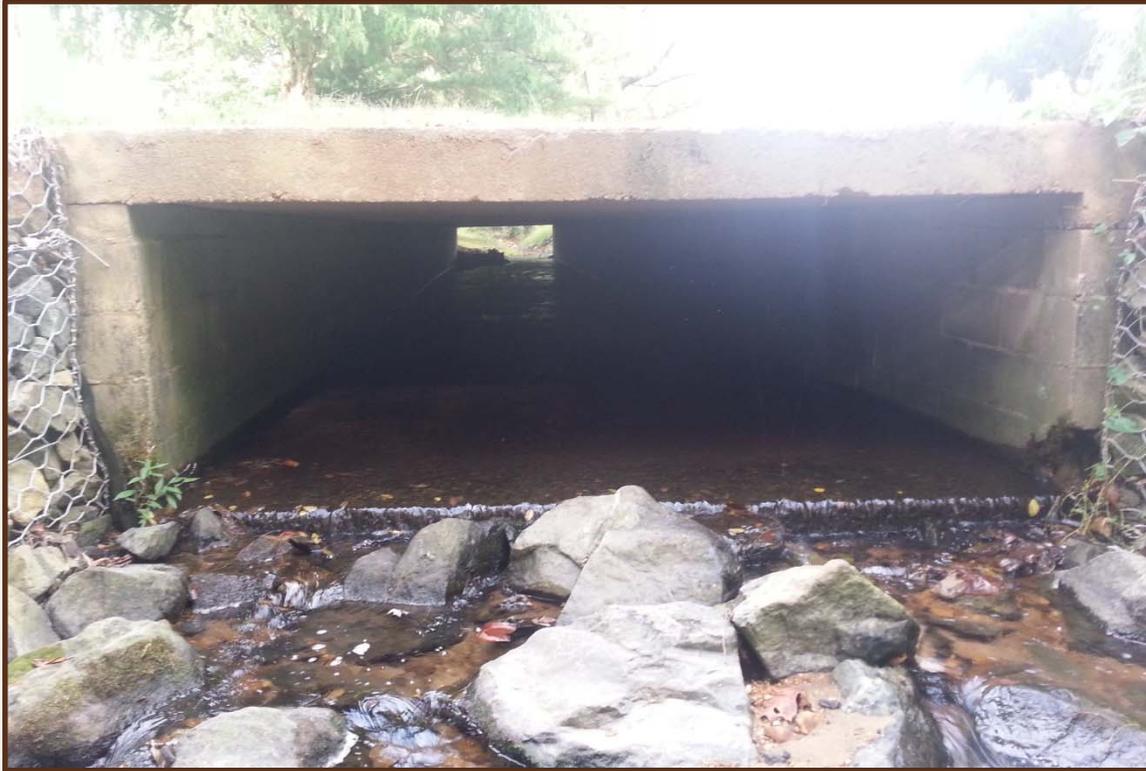
## Timberline Culvert

Past erosion issues at edges of wall and invert of box culvert.

- Long Term Action Items
  - Timberline Culvert
    - Prepare drainage area model to determine system capacity
    - Develop construction project for box culvert replacement
