# STORMWATER INFRASTRUCTURE

COMMUNITY RESPONSIBILITY

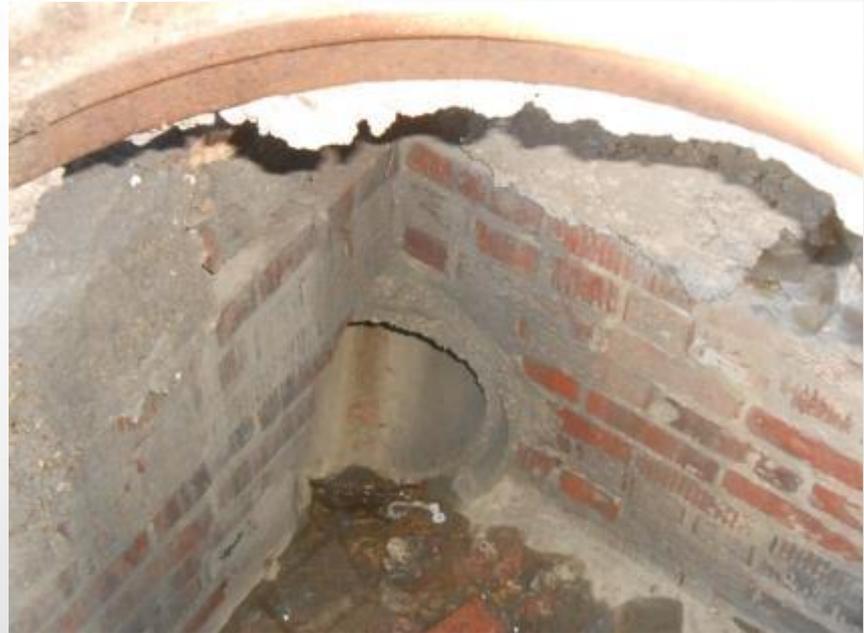
# EAST MAIN STREET – INLET 366

NEAR 133 EAST MAIN STREET  
24" DIAMETER INFLOW PIPE ,  
15" DIAMETER OUTFLOW PIPE

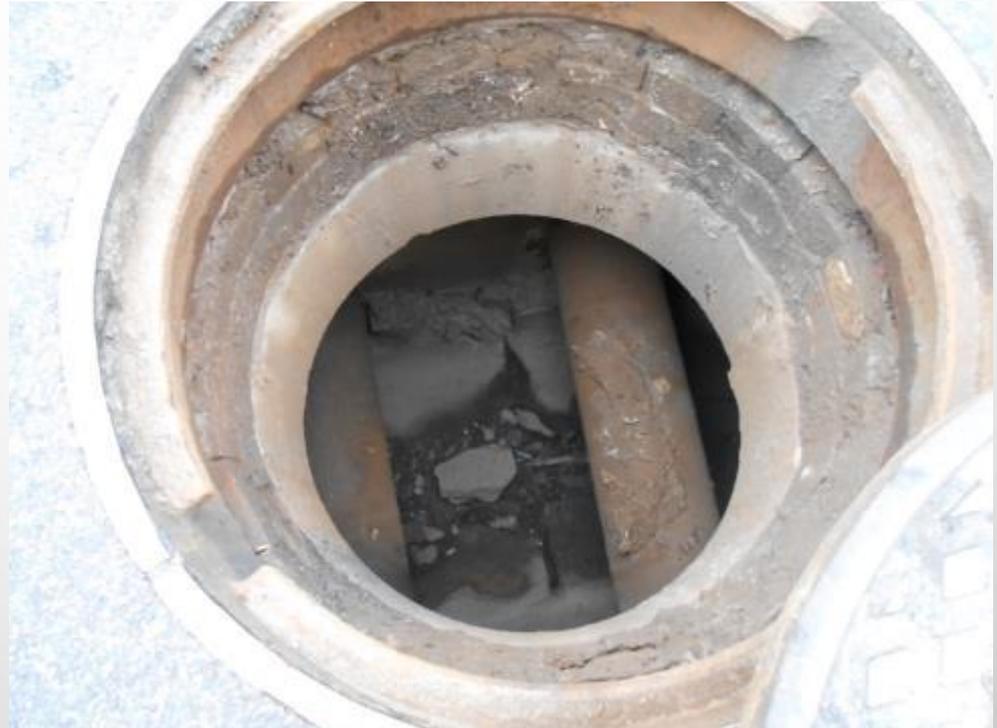
# EAST MAIN STREET – MANHOLE 78

BETWEEN HAINES AND CENTER  
STREETS

UTILITIES CROSSING THROUGH  
MANHOLES

PHOTO LOOKING INTO  
MANHOLE 78 FROM STREET  
LEVEL.

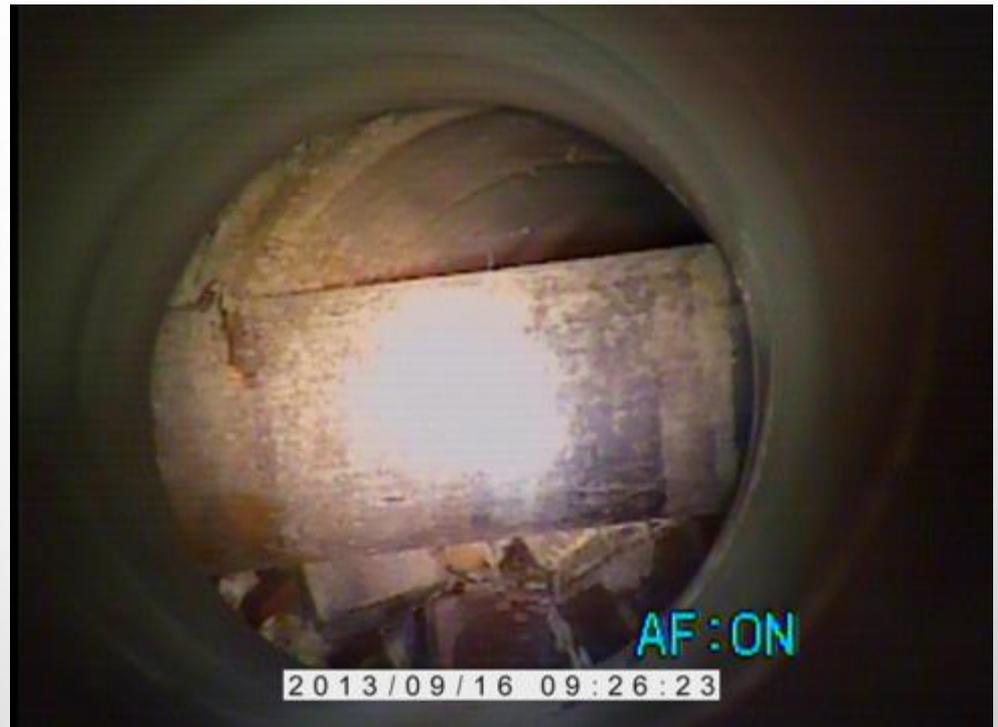
# EAST MAIN STREET BLOCKAGE

JUST WEST OF ACADEMY STREET

INTERNAL PIPE PHOTO LOOKING  
UPSTREAM FROM INLET 66

UTILITY CROSSING THROUGH  
PIPE WITH DEBRIS

ACCUMULATION. NO METHOD  
OF ACCESS FOR DEBRIS  
REMOVAL

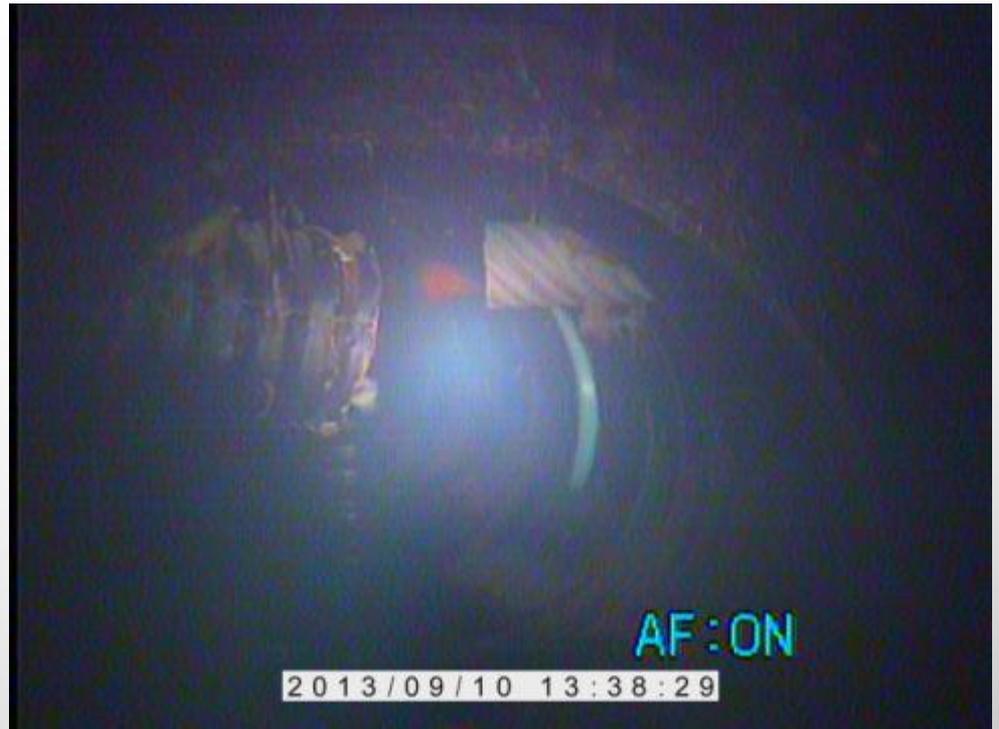
# PIPE PROTRUSION DOWNSTREAM OF MH1-D

HDPE FROM EAST; CMP FROM  
WEST

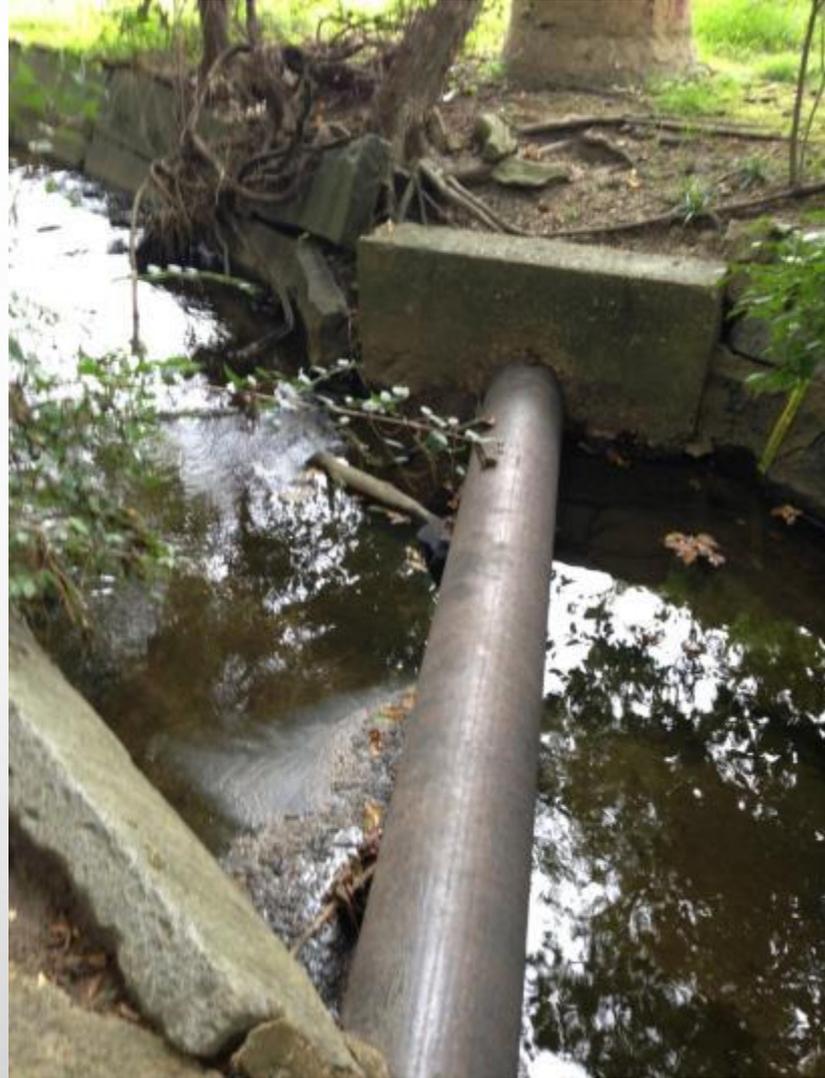
# SANITARY SEWER CROSSING STORM CHANNEL

SANITARY SEWER MAIN  
CROSSING STONE STORM  
CHANNEL AT EAST END OF KELLS  
AVENUE TO BE ADDRESSED BY  
SANITARY SEWER PROJECT

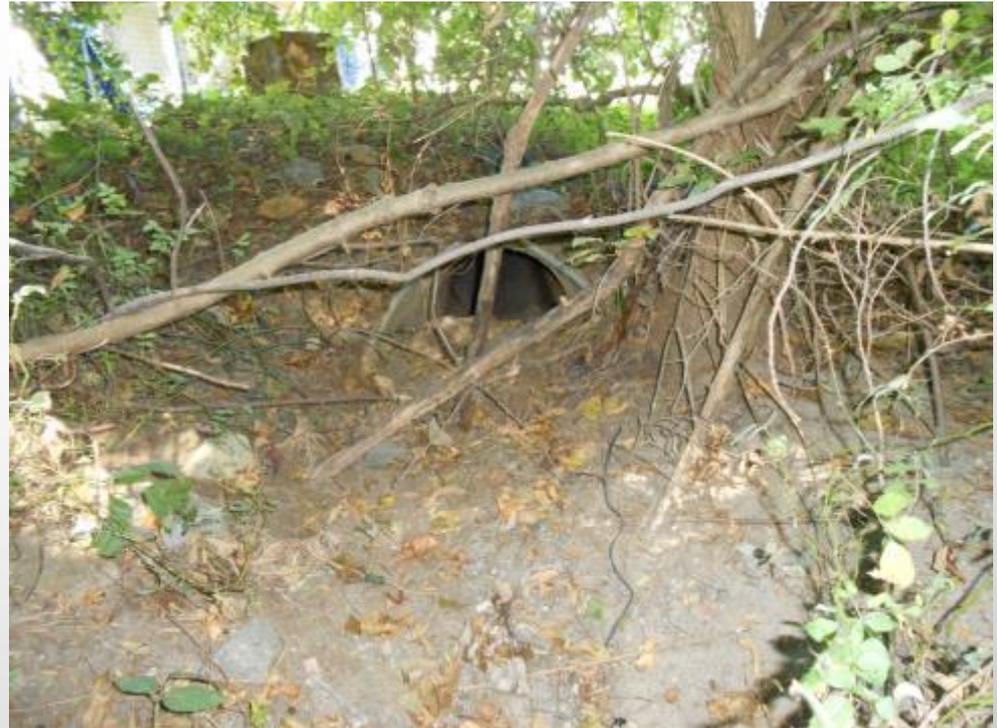
# JULIE LANE – END SECTION 69

VEGETATION AND YARD WASTE  
BLOCKING THE OUTLET.

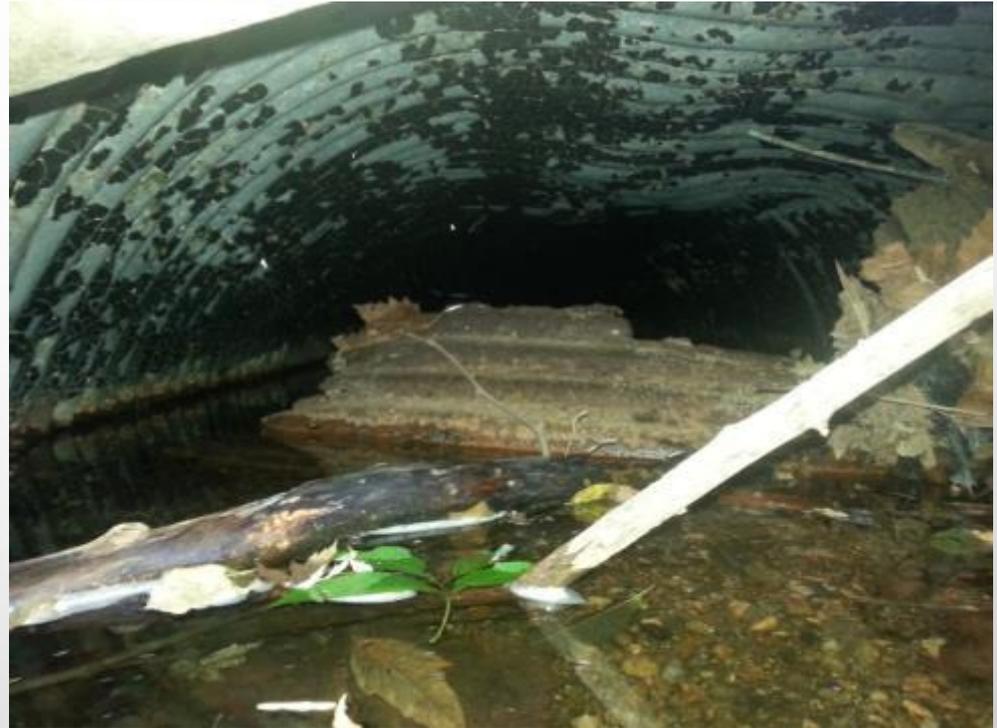
# PAPER MILL ROAD CULVERT

THE EXISTING CORRUGATED  
METAL PIPE IS PARTIALLY  
BLOCKED BY SEDIMENT AND PIPE  
FRAGMENTS. THE PIPE  
CONDITION IS SEVERELY  
DETERIORATED.

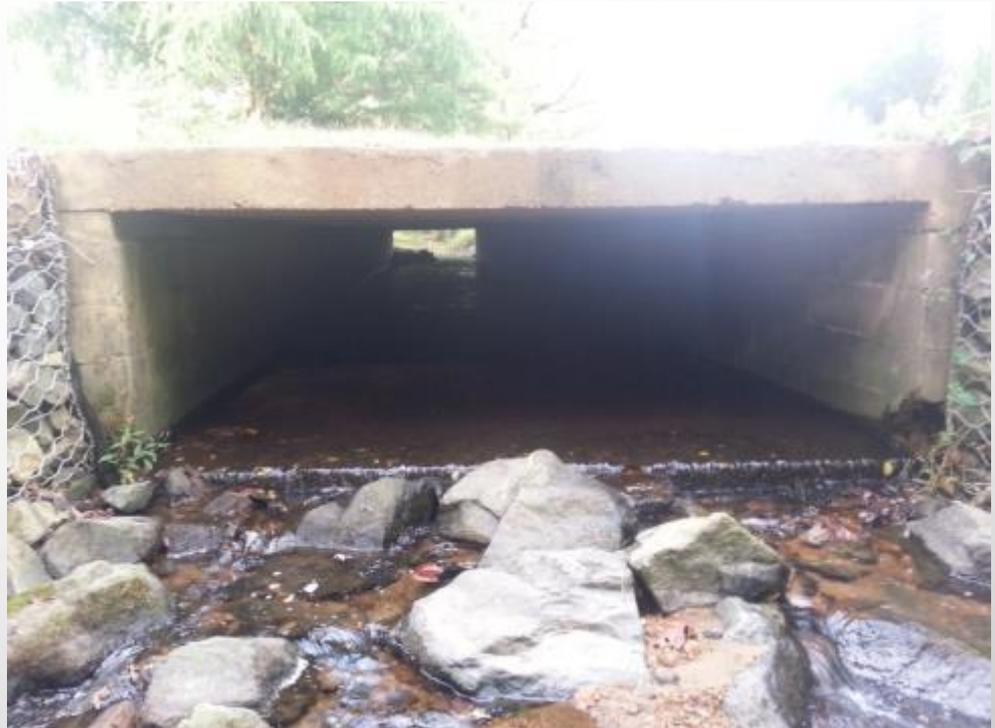
# TIMBERLINE CULVERT

TIMBER CREEK CULVERT IS  
UNDERSIZED CAUSING THE  
ROAD TO OVERTOP DURING  
HEAVY RAINFALL

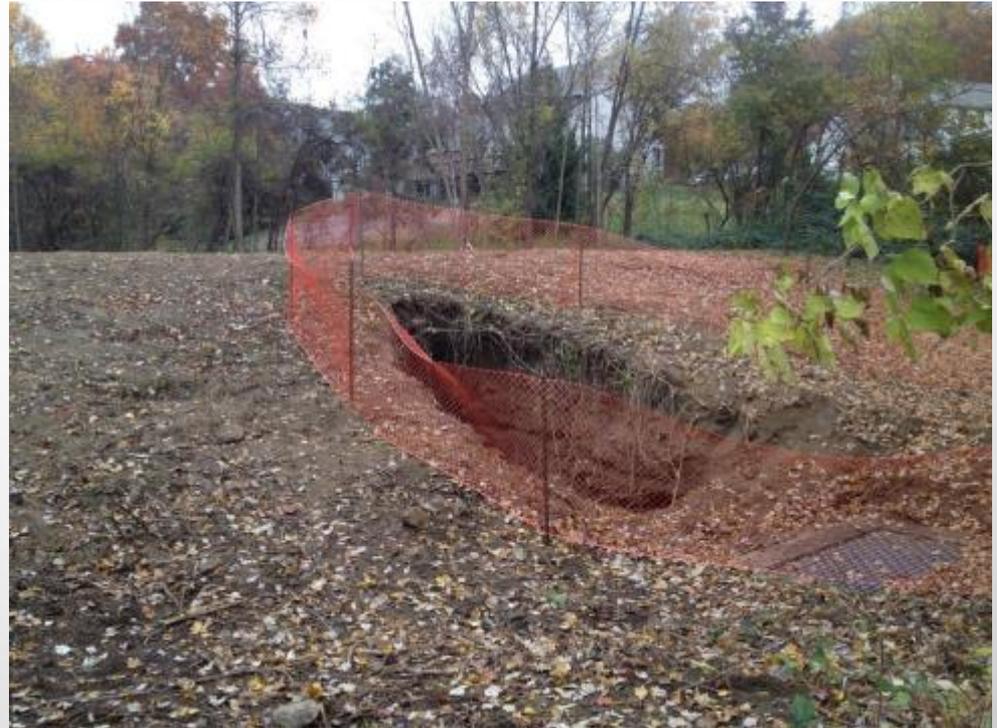
# RIDGEWOOD GLEN STORMWATER POND

THE EMBANKMENT FOR THIS POND FAILED IN 2013 DUE TO FAILURE OF THE OUTFALL PIPE THROUGH THE EMBANKMENT. THERE ARE SEVERAL HOUSES WHICH FRONT CREEK BEND DRIVE IMMEDIATELY DOWNSTREAM FROM THE FAILING EMBANKMENT.

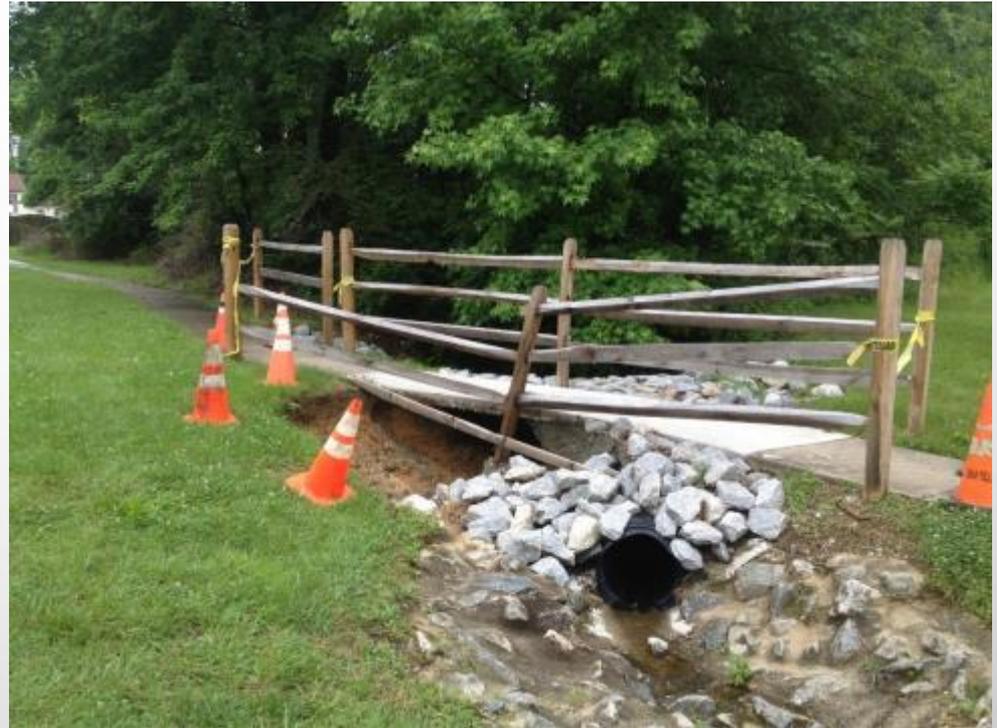
# CASHO MILL ROAD AT BARKSDALE ESTATES

EROSION OF PEDESTRIAN  
WALKWAY FROM STORMWATER  
RUNOFF CAUSING A  
HAZARDOUS CONDITION.

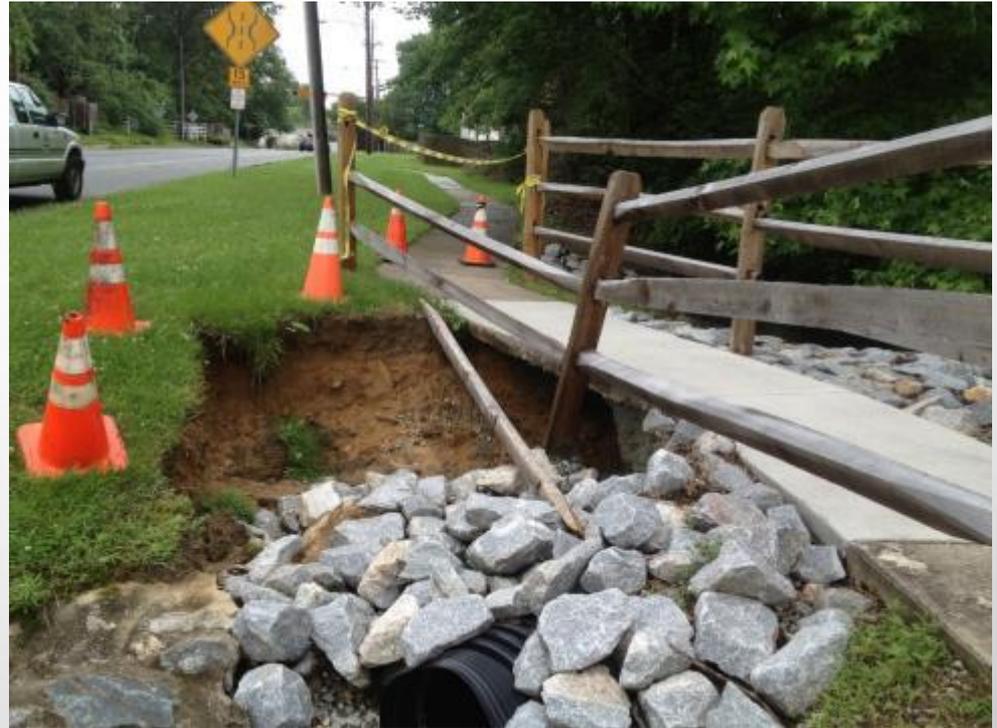
# CASHO MILL ROAD AT BARKSDALE ESTATES

ANOTHER ANGLE SHOWING  
THE UNDERMINED WALKWAY

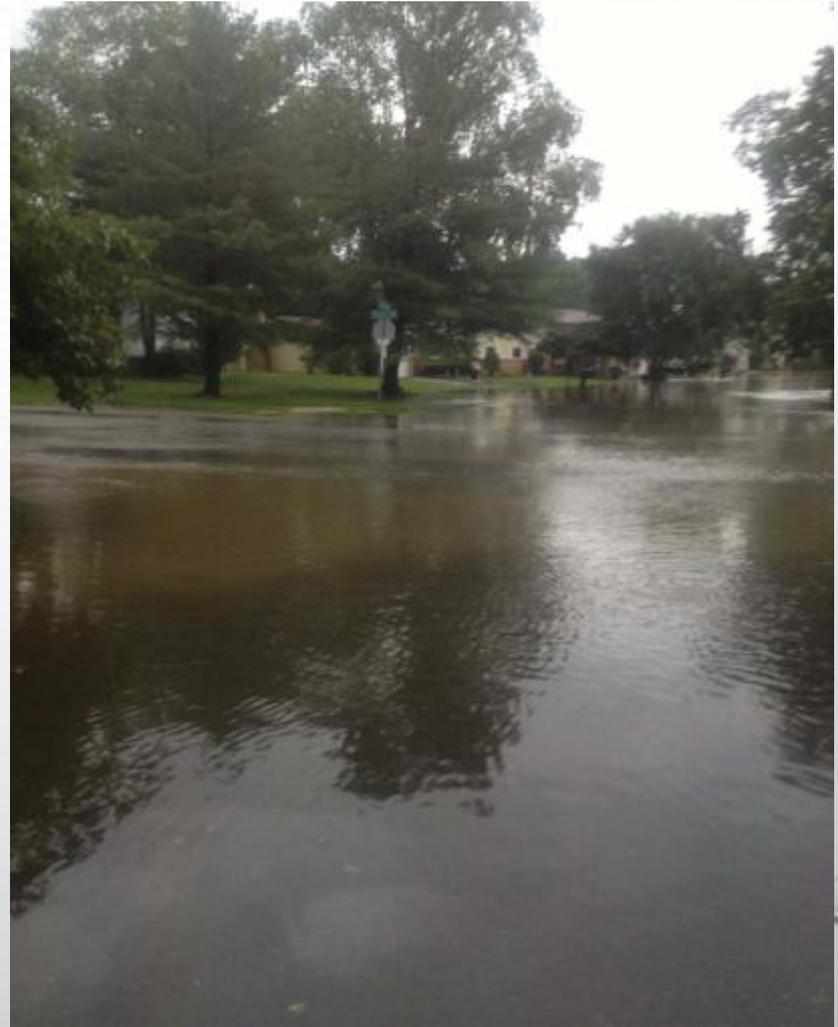
# CHRYSLER AVE AND SHULL DR 8/13/13

SEVERE FLOODING EXPERIENCED  
IN DEVON PLACE DURING THE  
MORNING STORM OF AUGUST  
13<sup>TH</sup>, 2013.

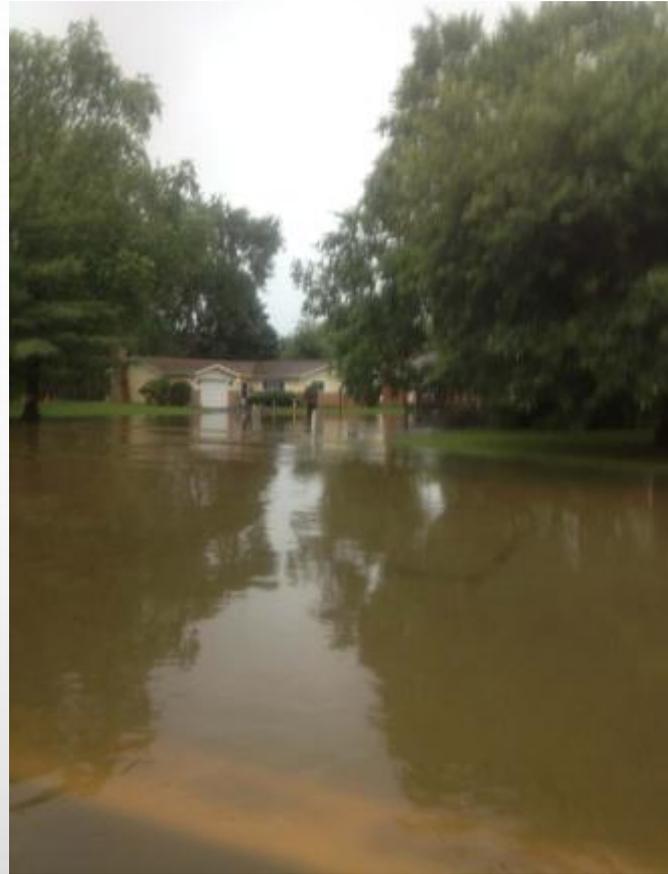
**CHRYSLER AVE  
AND SHULL DR  
8/13/13**

SEVERE FLOODING EXPERIENCED  
IN DEVON PLACE DURING THE  
MORNING STORM OF AUGUST  
13<sup>TH</sup>, 2013.

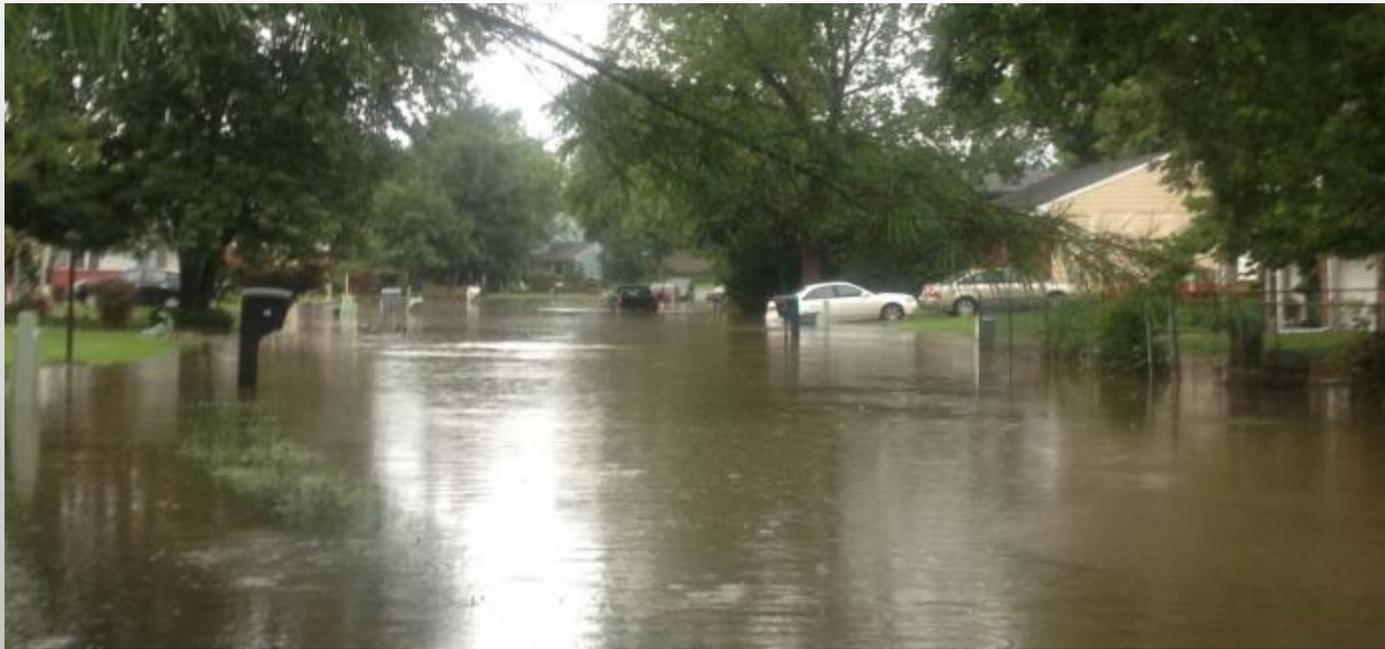
**CHRYSLER AVE  
AND SHULL DR  
8/13/13**

SEVERE FLOODING EXPERIENCED  
IN DEVON PLACE DURING THE  
MORNING STORM OF AUGUST  
13<sup>TH</sup>, 2013.

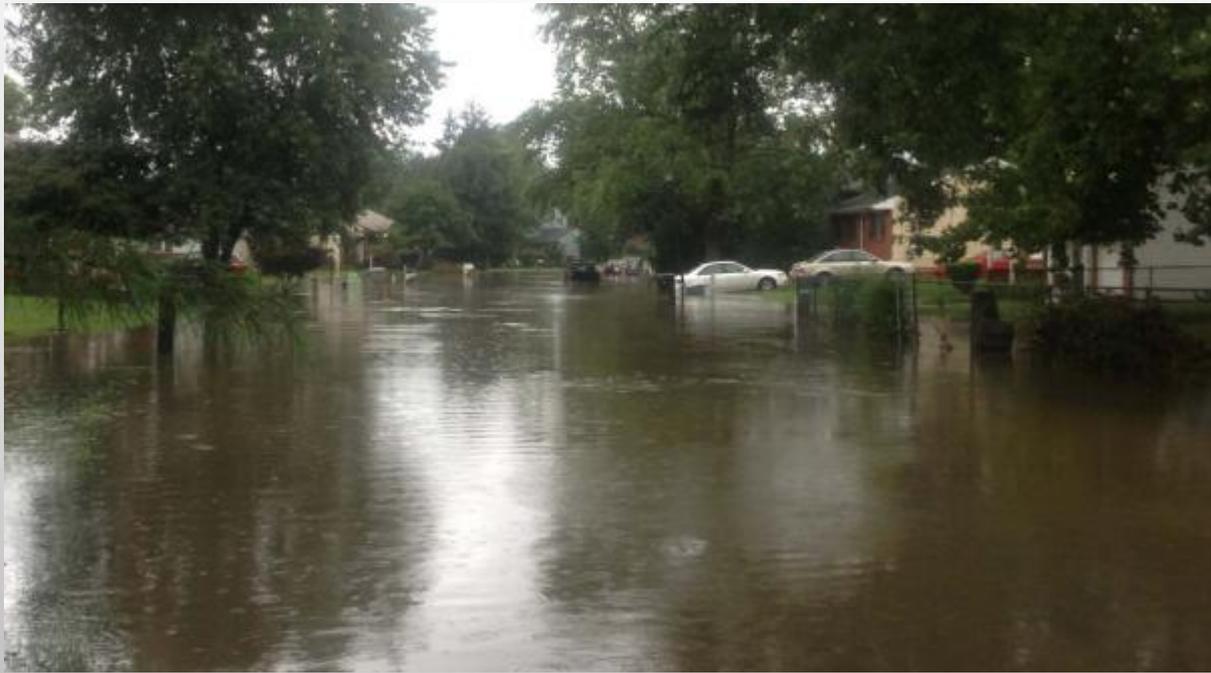
**CHRYSLER AVE  
AND SHULL DR  
8/13/13**

SEVERE FLOODING EXPERIENCED  
IN DEVON PLACE DURING THE  
MORNING STORM OF AUGUST  
13<sup>TH</sup>, 2013.

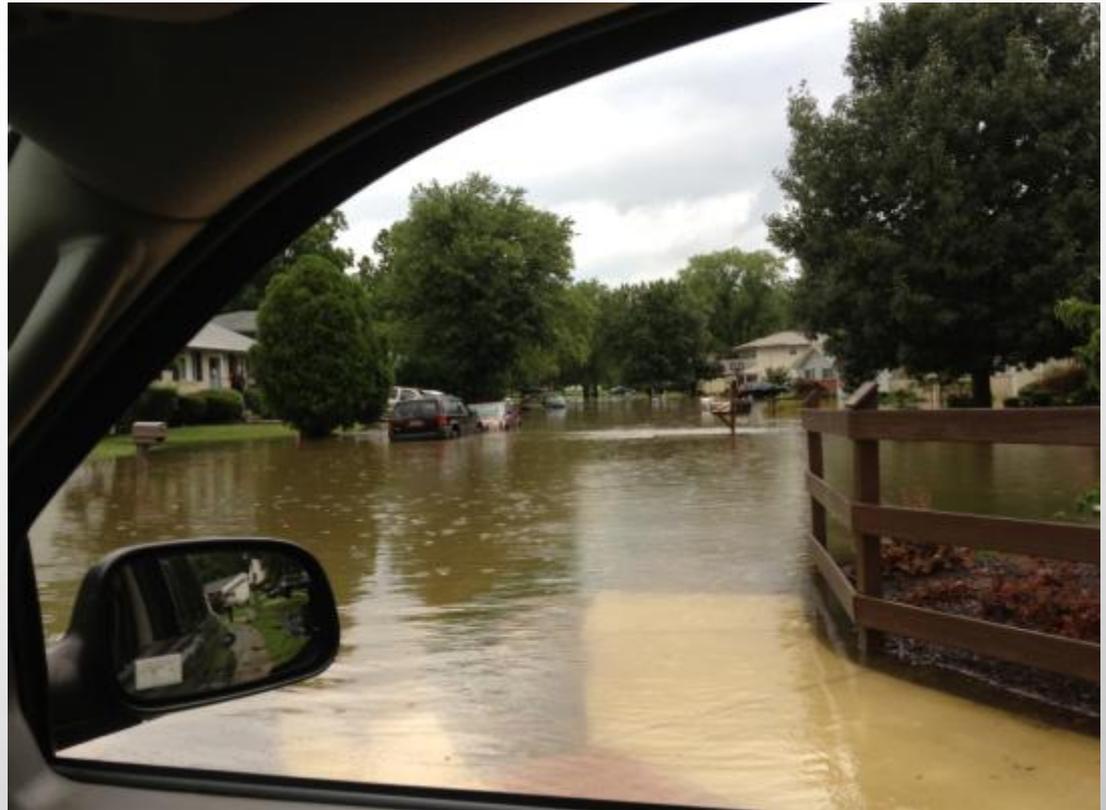
# CHRYSLER AVE AND SHULL DR - 8/13/13

SHULL DRIVE LOOKING NORTH  
FROM THE INTERSECTION WITH  
LEEDS LANE FOLLOWING THE  
STORM ON AUGUST 13<sup>TH</sup>, 2013

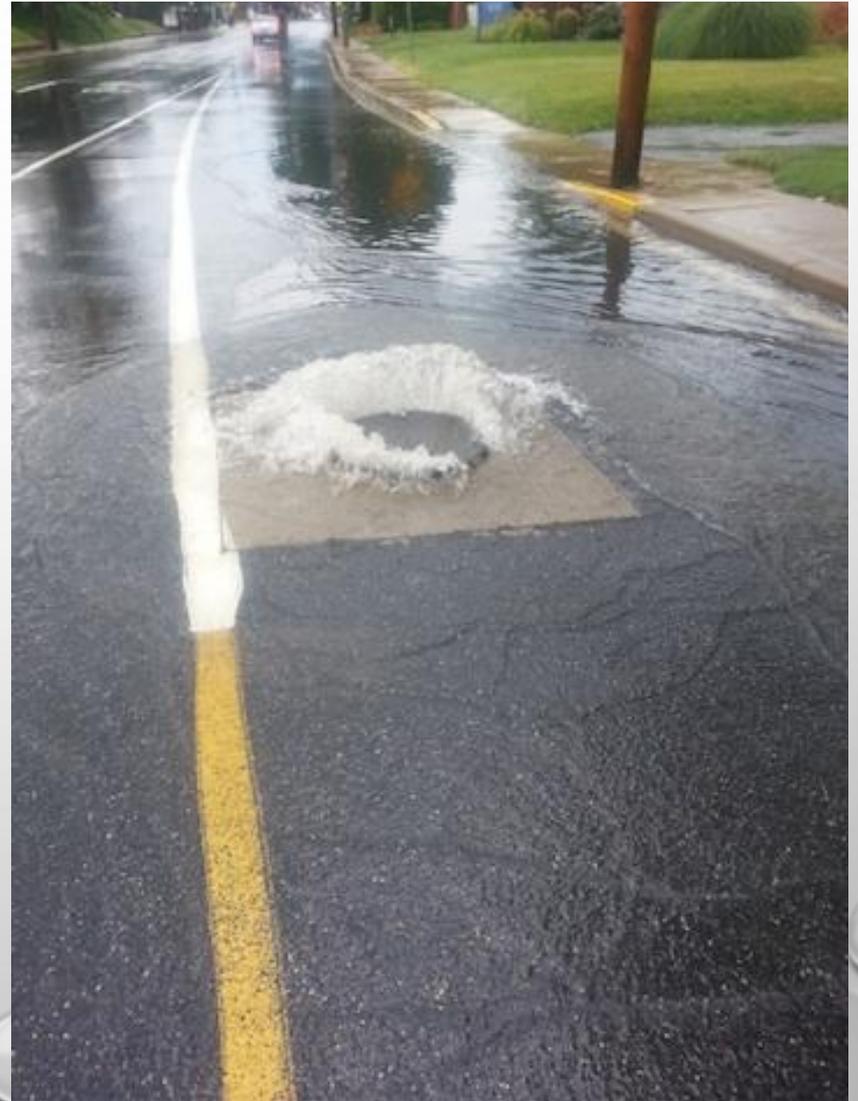
# EAST MAIN STREET-8/13/13

WATER GUSHED OUT OF THIS  
MANHOLE ON EAST MAIN  
STREET NEAR THE NEWARK  
LIBRARY. THE GUSHING WATER  
INDICATES THAT THE SEWER  
SYSTEM COULD NOT PROPERLY  
HANDLE THE RAINFALL

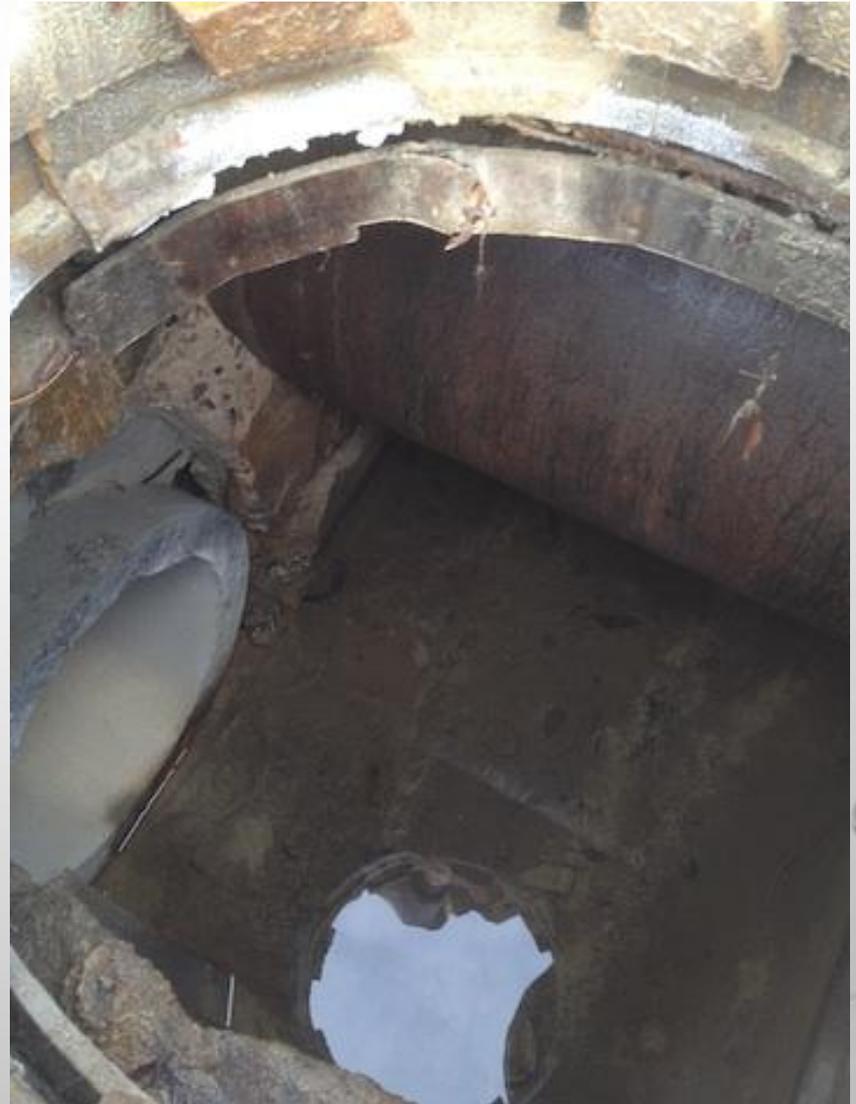
# ACADEMY STREET – 1/31/14

LARGER PIPE IMPEDING THE  
FLOW OF THE DRAINAGE PIPE

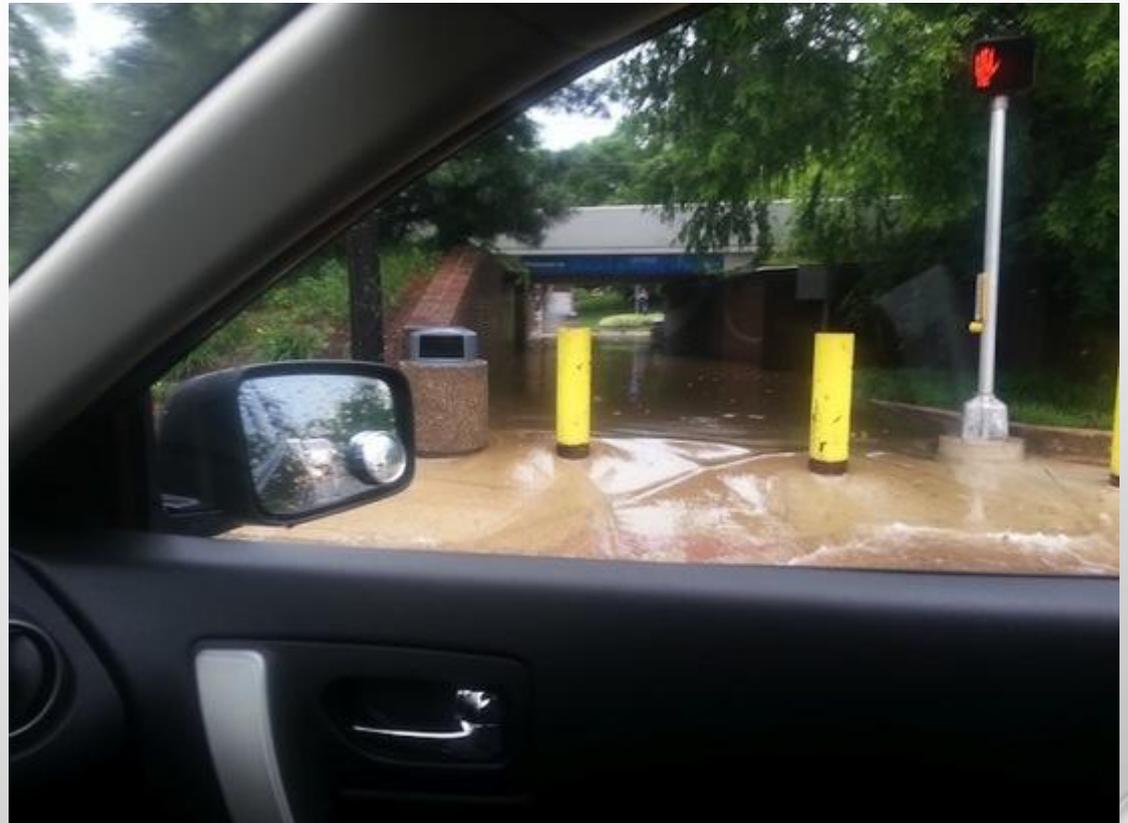
# RODNEY UNDERPASS 8/13/13

THIS PHOTO WAS TAKEN AFTER  
THE RAINFALL BUT STILL SHOWS  
THE EXTENT OF THE FLOODING  
IN THE RODNEY UNDERPASS

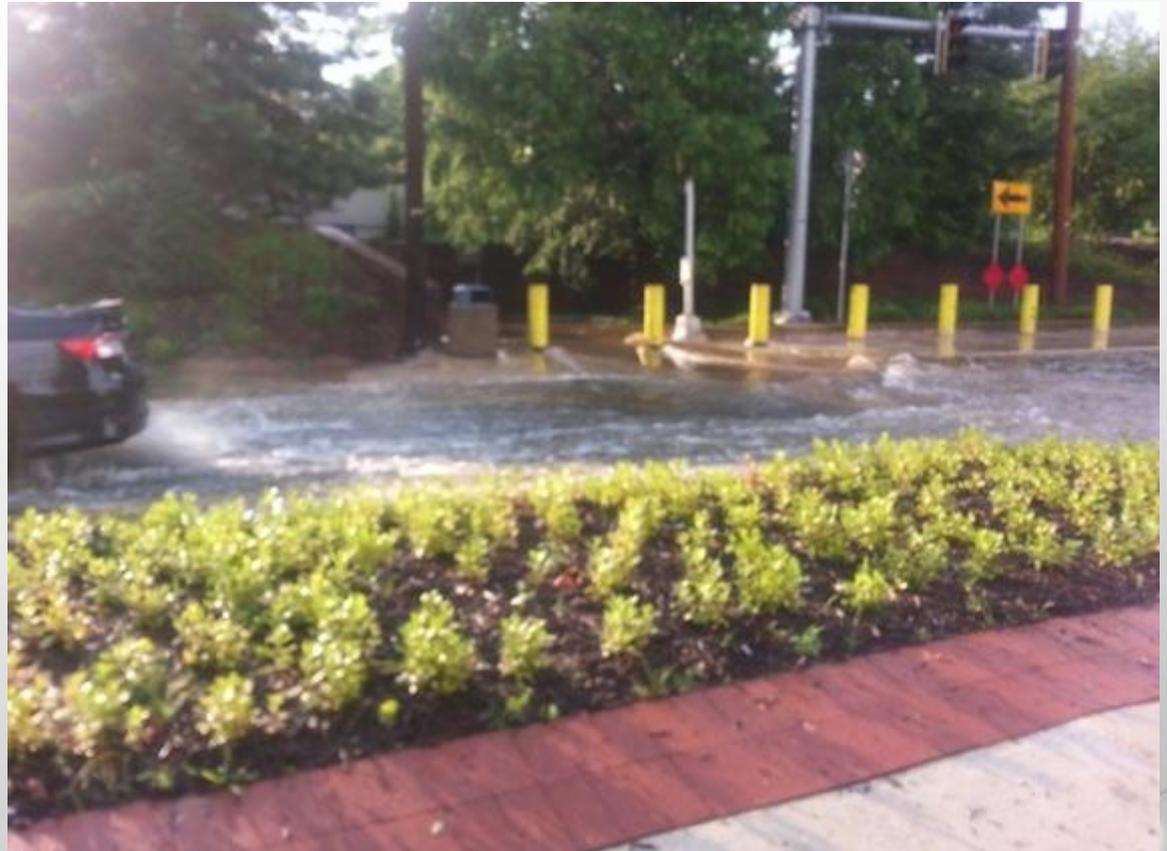
# RODNEY UNDERPASS 8/13/13

THIS PHOTO WAS TAKEN AFTER  
THE RAINFALL BUT STILL SHOWS  
THE EXTENT OF THE FLOODING  
IN THE RODNEY UNDERPASS
