Stormwater Fund for the City of Newark

Full List of Identified Problem Areas and Potential Costs

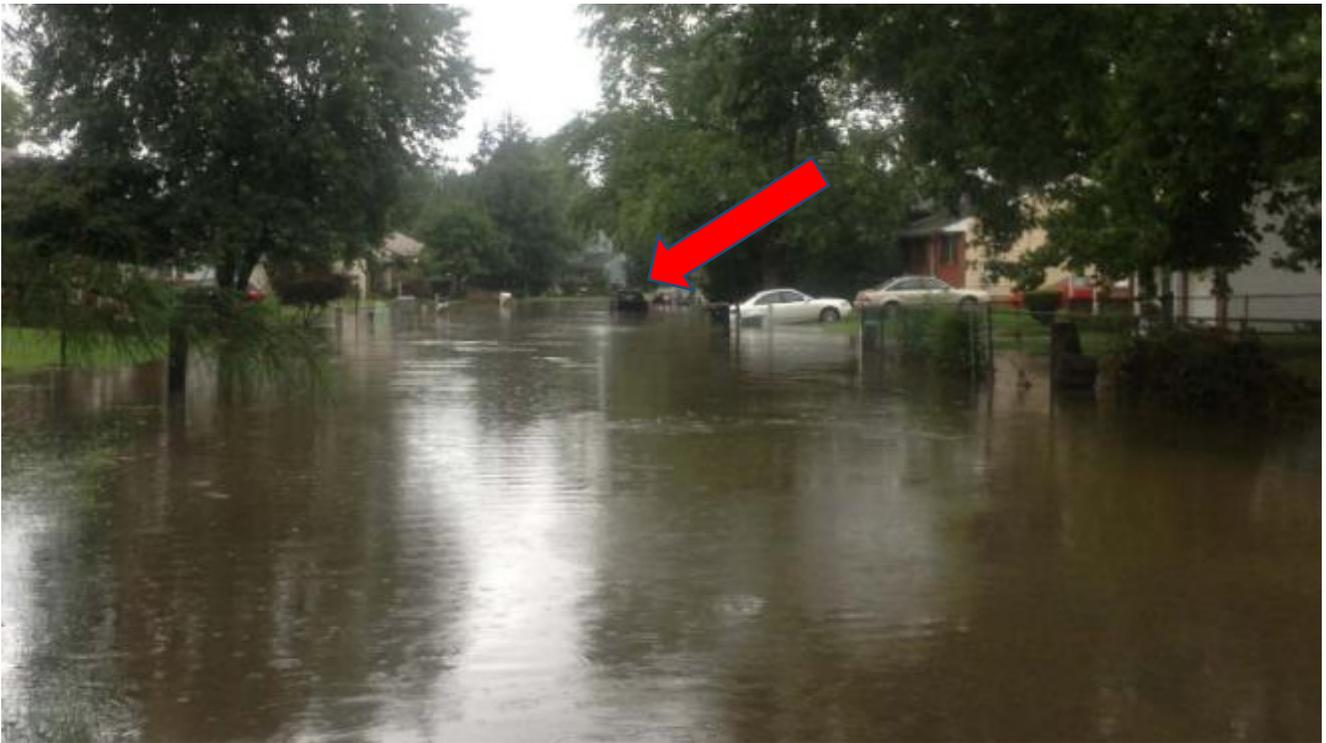
- The current system is over **60 years old**
- Limited storm sewer systems in place (Lehigh Rd., Kenyon Ln., Chrysler Ave., Swarthmore Rd., Susquehanna Cir., Alexandria Dr., Devon Dr., Cornwall Dr., and Shull Dr.)
- Grading, above ground structures and vegetation inhibiting effectiveness of inlets in the easement areas.
- No storm water routes for runoff associated with larger storms.
- Obstruction in front of headwall 279 on Amtrak property
- Had to remove debris from grate of inlet 228 and 229 in private yard to gain access to pipe.
- Vegetation and Obstructions

Figure 1 Shown here is Swarthmore Road and Devon Place severely affected by the flooding of the August 13, 2013 storm. The flooding was extensive enough to reach the bed of the pick-up truck in the background.

- Devon Place Survey, Modeling Engineering Costs with an estimated cost of **\$24,300**
- Devon Place Storm Sewer Improvements Including Engineering Services with an estimated cost of **\$1,313,000**
