Upper Christina River Stream Restoration Project

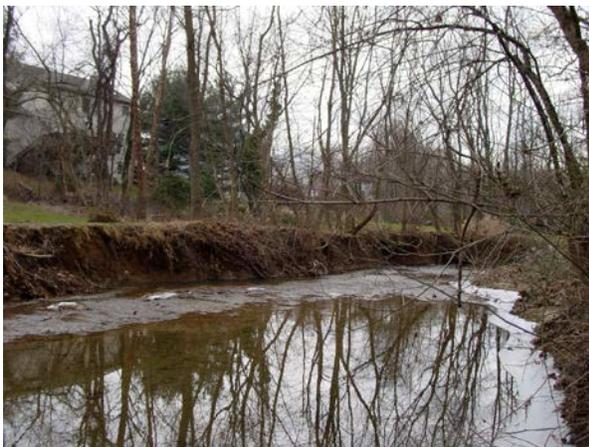
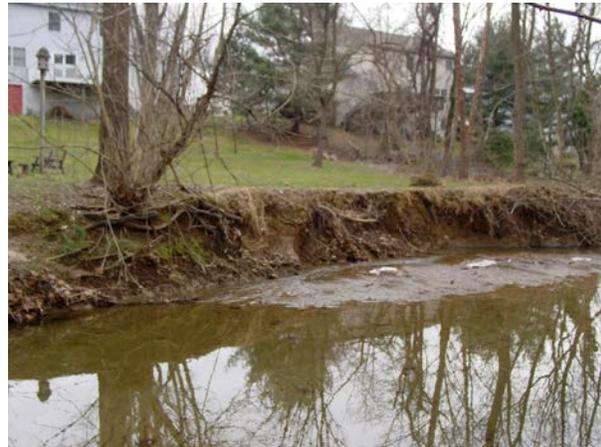
The lack of proper riparian buffer vegetation and maintenance is evidenced by lawn grass being cut to the edge of the bank. The shallow root systems of the plants cannot hold the soils in place.

Implementing the appropriate stream restoration techniques will help stabilize the stream banks resulting in reduced sediment and nutrient loading to the Christina, improvements to habitat and water quality, and will allow the channel to be resized for the flow volumes that pass through the systems during average storm events. Bank-toe boulder protection and vegetative plantings, along with other stream restoration construction techniques, will be utilized to stabilize the degrading stream banks and improve habitat and water quality and reduce the loss of property.

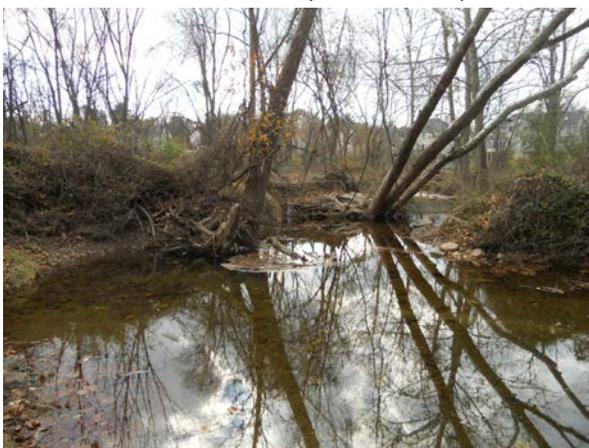
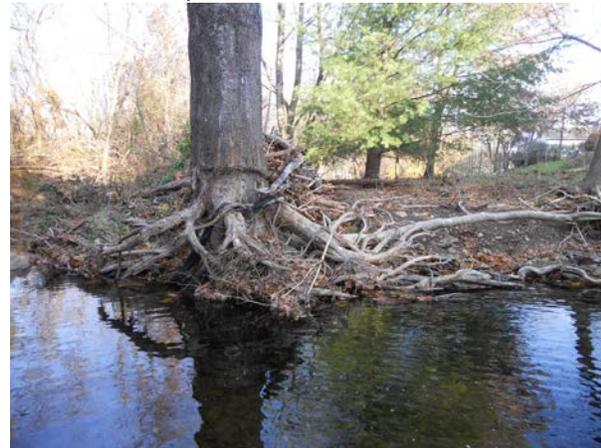
Stream bank erosion and bank undercutting has caused numerous mature trees to fall into the stream as evidenced by the photo above (left). Exposed roots (right) depict the large volume of topsoil that has been removed by stream erosion, jeopardizing the fate of mature trees as shown in the photo.

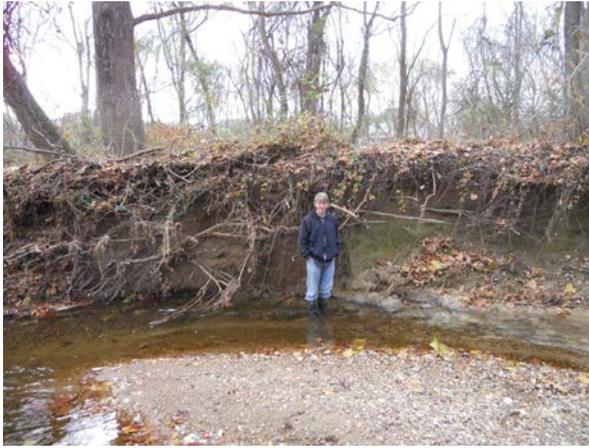
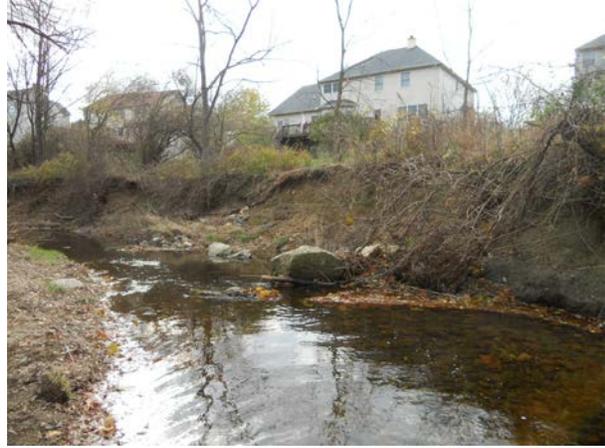
A deeply-incised stream channel and vertical stream banks along the Upper Christina River. Excessive volumes of sediment are being deposited into the stream channel resulting in the loss of property and wildlife habitat. In some areas along the Upper Christina dwellings are being threatened due to the rapidly-eroding stream banks.

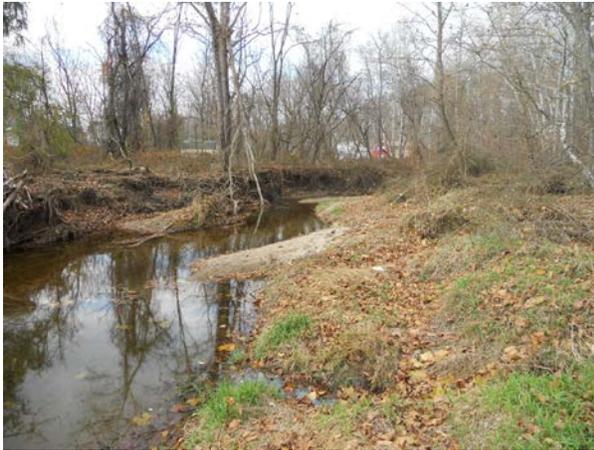
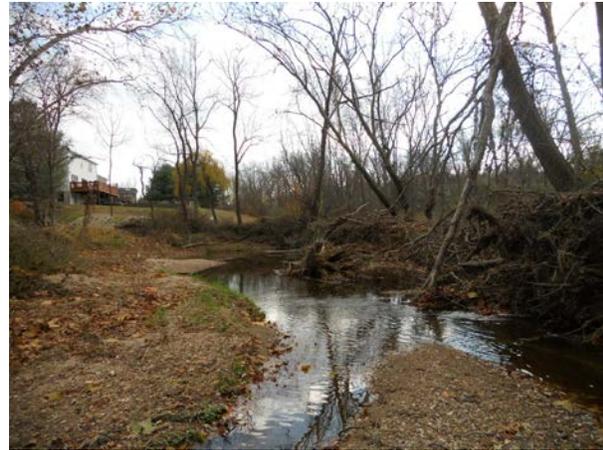
The unstable nature in this reach of the Upper Christina River is demonstrated by the in-stream sediment bars that have formed. The overabundance of bed load material deposited in the center of the channel is shown above.
