**TITLE:** Upper Christina River Stream Restoration Project

## **Background**

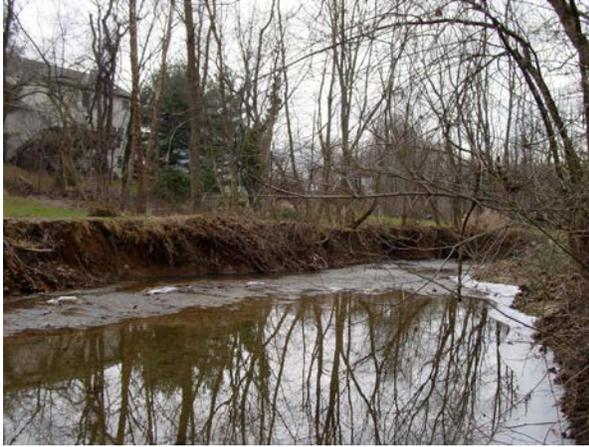
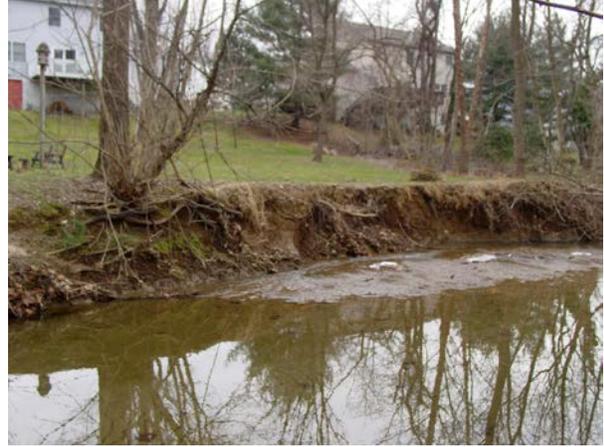
The lack of proper riparian buffer vegetation and maintenance is evidenced by lawn grass being cut to the edge of the bank. The shallow root systems of the plants cannot hold the soils in place.

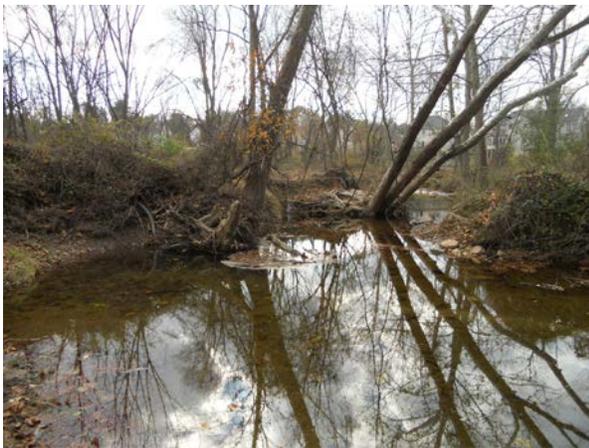
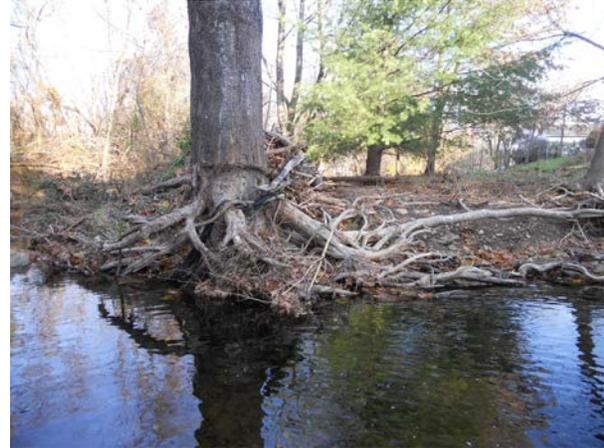
Stream bank erosion and bank undercutting has caused numerous mature trees to fall into the stream as evidenced by the photo above (left). Exposed roots (right) depict the large volume of topsoil that has been removed by stream erosion, jeopardizing the fate of mature trees as shown in the photo.

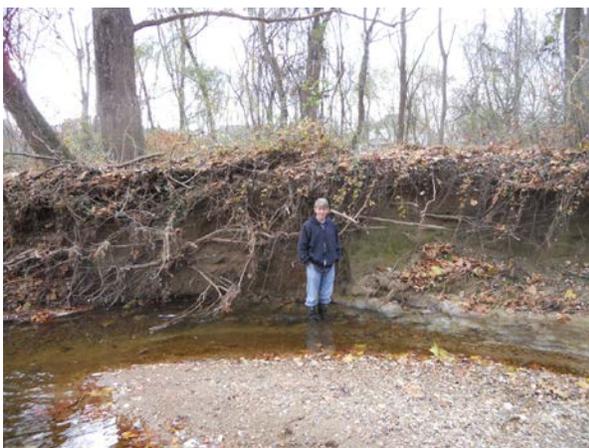
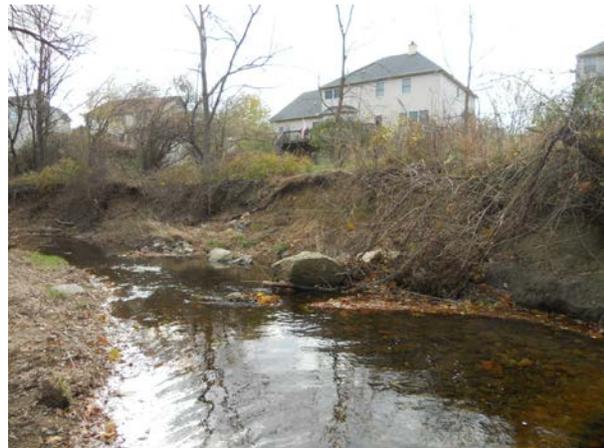
A deeply-incised stream channel and vertical stream banks along the Upper Christina River. Excessive volumes of sediment are being deposited into the stream channel resulting in the loss of property and wildlife habitat. In some areas along the Upper Christina dwellings are being threatened due to the rapidly-eroding stream banks.

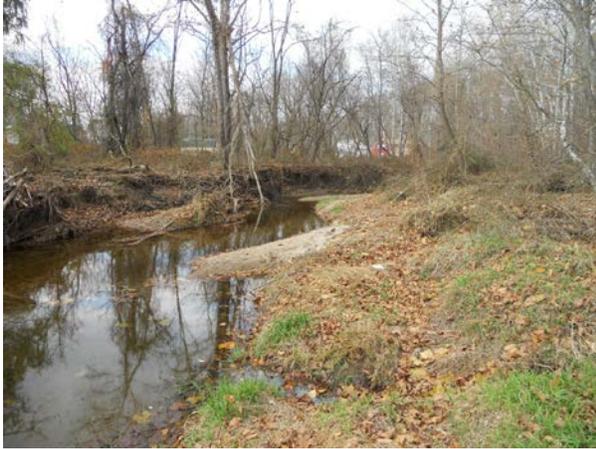
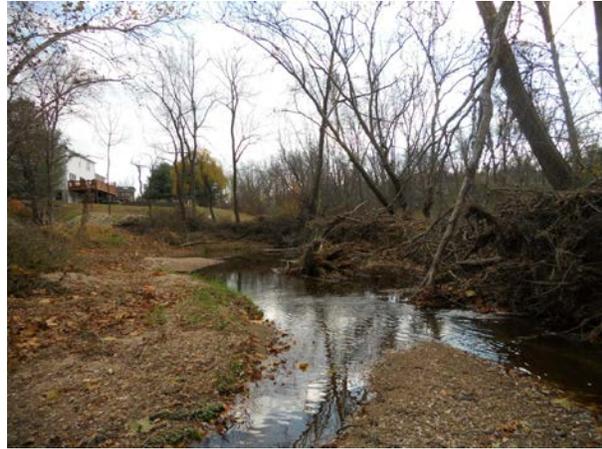
The unstable nature in this reach of the Upper Christina River is demonstrated by the in-stream sediment bars that have formed. The overabundance of bed load material deposited in the center of the channel is shown above.

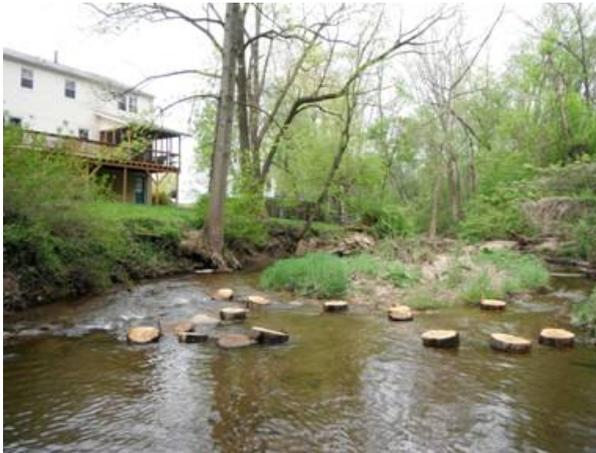
Photo on the left shows a sand bar which has accumulated in the center of the channel. The dwelling to the left is being threatened by the eroding bank conditions. Pieces of firewood are floating downstream following a heavy storm event. Photo on right shows exposed tree roots which indicate the large volumes of sediment that have eroded away from this cut-bank (these trees have fallen into the stream since photo was taken over a year ago). The banks need to be stabilized to reduce erosion.
