**CITY OF NEWARK  
DELAWARE**

**CITY COUNCIL  
WORKSHOP AGENDA**

## Storm Sewer Investigation and Planning

- Storm Sewer Investigation
  - Pennoni was hired to assist Newark with visual observation and assessment.
  - Used Envirosight pole camera to scope existing system for existing and potential future problems.
  - Video information supplemented with notes and photographs.

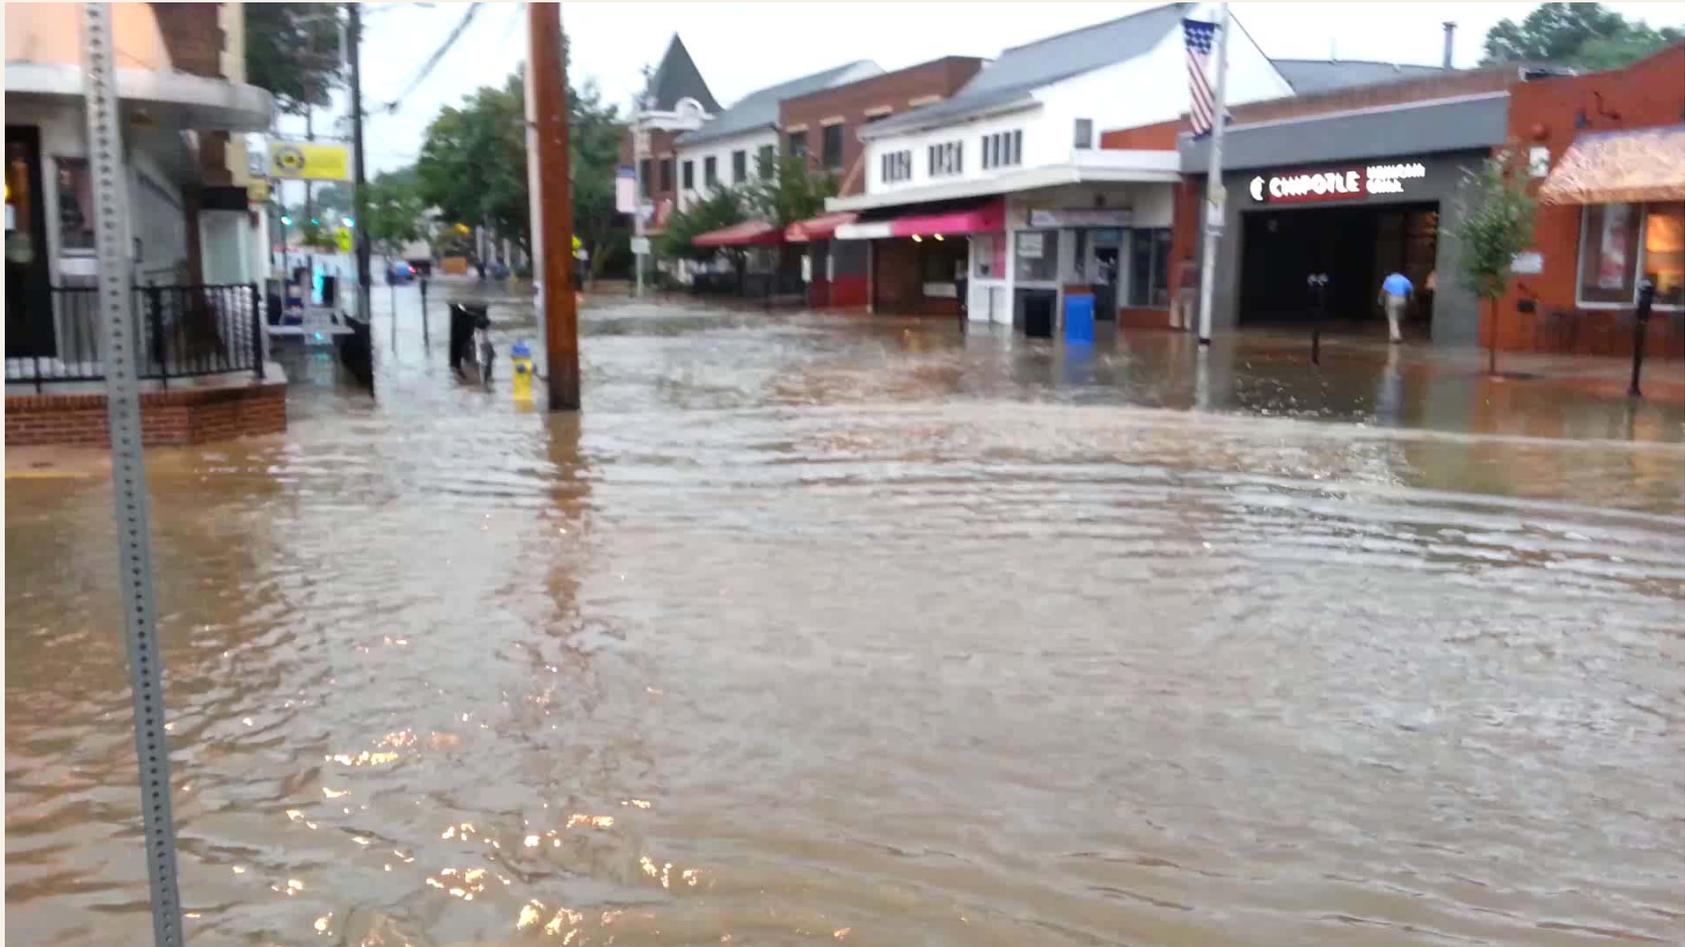
# East Main Street

- East Main Street and Haines Street
  - Recent rain events in Summer of 2013 caused flooding events on East Main Street at Haines Street
    - Video taken during storm event on August 13, 2013.
  - Issues discovered
    - Large pipe upstream of small pipe
    - Utility pipes crossing through manhole
    - Utility pipes crossing through storm sewer
    - Protruding pipe connections into storm sewer

- Long Term Action Items
  - East Main Street
    - Remove or relocate utility crossings where possible or install access points at the crossings to enable maintenance for removal of debris
    - Prepare drainage area model to determine system capacity
    - Develop construction project to address capacity problems and replacement of deteriorated pipe if necessary
    - Consider modifications to City regulations regarding storm sewers
